# ROAD BRIDGES IN MINAMI-SANRIKU WASHED AWAY IN THE MARCH 11<sup>th</sup> 2011 GREAT EAST JAPAN EARTHQUAKE AND TSUNAMI

Mary Roxanne I. AGLIPAY<sup>1</sup>, Kazuo KONAGAI<sup>2</sup>, Hiroyuki KYOKAWA<sup>3</sup> and Sharma KESHAB<sup>1</sup>

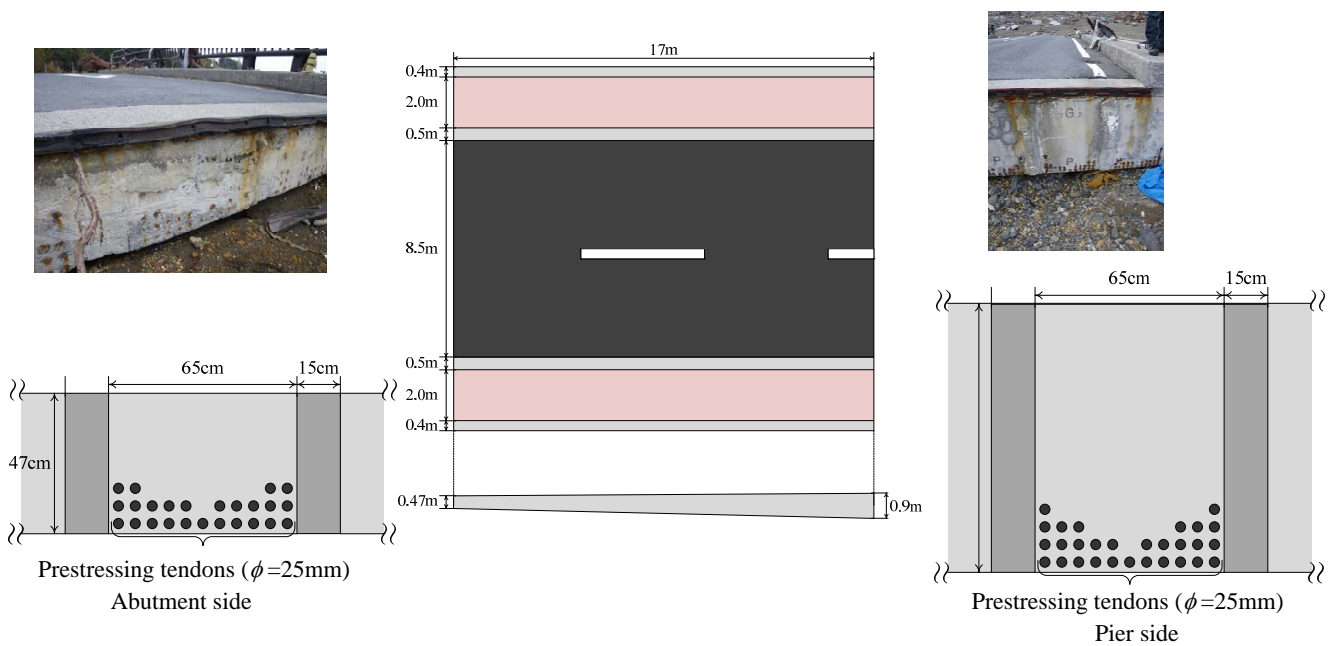
Figure 3 Shape and configuration of Oritate Bridge Deck

Originally, the road bridge is composed of 2 spans; each is approximately 17.5m long with the double lane roadway of approximately 8.5m width and pedestrian carriages on both sides, each with 2.0m width (Figure 3). The decks are composed of 16 precast pre-stressed concrete box beams aligned parallel with one another. Each beam is tapered

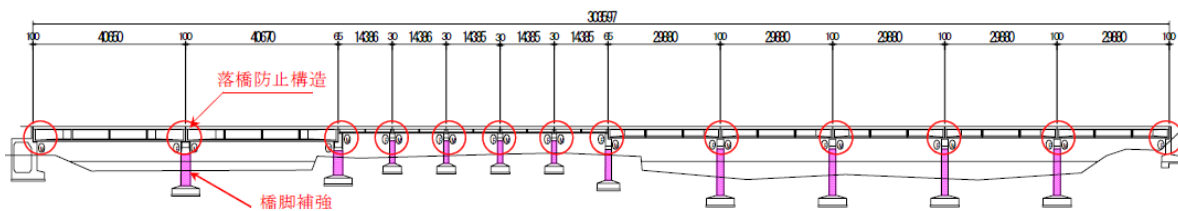
**Figure 13** Aseismic retrofit plan for Utatsu Bridge<sup>5)</sup>

decks over waters and 5 middle decks over land (**Figure 13**). The bridge was retrofitted in 2004 and 2005 in such a way that steel brackets were fixed to pier tops to be interlocked with main pre-stressed concrete beams of the bridge, thus confining the beams' transverse movements<sup>4, 5</sup>, and yet 8 decks of total 12 were found carried over several tens meters distances inland as shown in Figure 14. These steel brackets were remaining almost intact on pier tops except for the northernmost ones on the inland side (**Figure 14**). Some bridge decks were lying upside down showing all their lattices of main

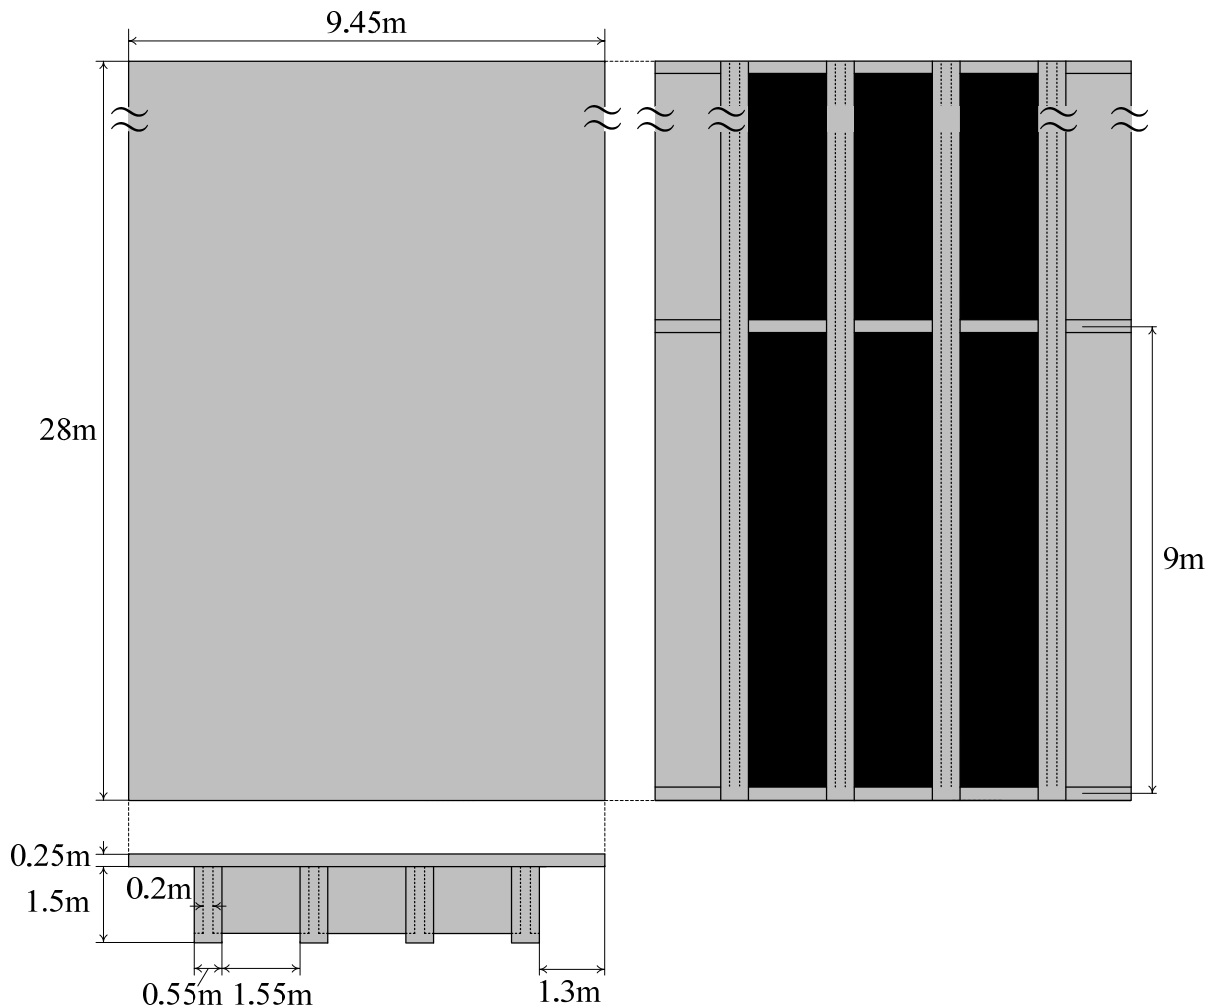
**Figure 16** Configuration of Utatsu Bridge Deck

and cross concrete beams about full of water (**Figure 15**). This fact indicated that the watertight lattices of main and cross concrete beams may have entrapped airs giving some remarkable buoyancy to bridge decks. The cross-section of the bridge deck shown in **Figure 16** indicates that the hollow volume among the lattice beams of about 223 m<sup>3</sup> is about 2.2 times as large as the entire volume of the bridge deck of 100 m<sup>3</sup>. Considering that the relative density of concrete is around 2.3, this volume of the hollow in the beam lattice may have been large enough for the weight of the deck to be almost

canceled in water.
