Evaluation of Fudai floodgate bridge damaged by tsunami

Shinichiro Mori¹ and Ratna Prasad Twayana²

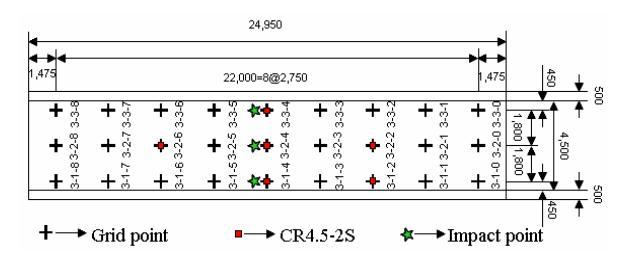
Fig.3 Plan view of sensor configuration and impact location on span 3 of Fudai floodgate bridge. (Note: All dimensions are in mm)
