# Situation of damage in and around Kathmandu Valley due to the 2015 Gorkha Nepal Earthquake

**Key Words :** Kathmandu Valley, damage estimation, scenario earthquake, building structure

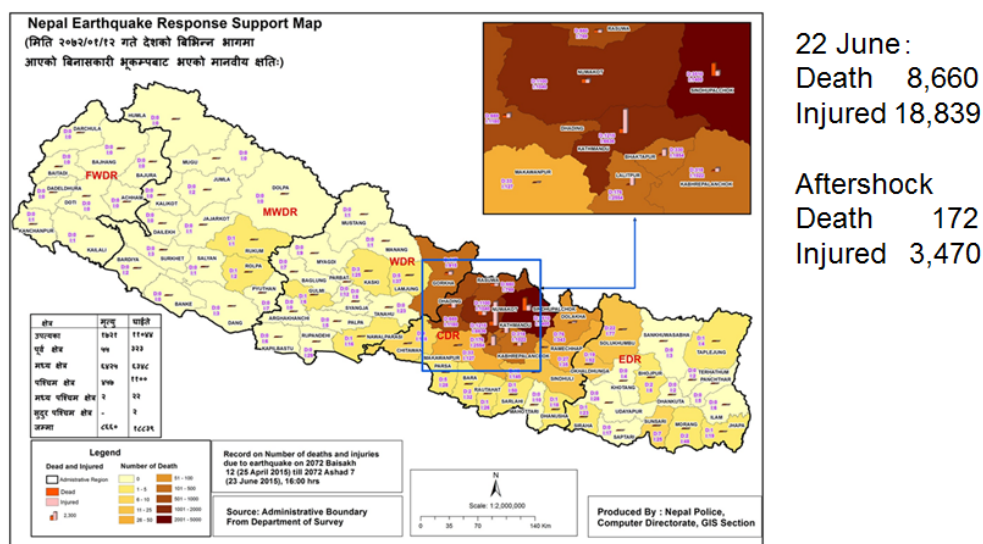
**Fig.5.2** Casualties and injured people by Nepal Police as of June 22, 2015

According to the Nepal Police statistics as of 22 June 2015, more than 500 thousand buildings and houses were damaged – and about half of those collapsed; that number is now increasing (**Fig.5.2**). First, the dominant rural housing style in the area consists mainly of stone or adobe masonry as well as mud mortar masonries<sup>11)</sup>. The collapse of heavy stone buildings killed many. The damage to houses in the mountainous region was typically concentrated in non-engineered structures. In rural areas, unreinforced masonry, sourced from regionally available
