A STUDY ON THE VIBRATIONAL CHARACTERISTICS OF RIGID-FRAME BRIDGES
AFTER THE HYOGO-KEN NAMBU EARTHQUAKE

(Translation from Proceedings of JSCE, No.550/V-33, November 1996)

Some of the elevated rigid-frame bridges on the New Tokaido line were damaged by the Hyogo-ken Nambu Earthquake. After restoration, the dynamic percussion test was performed by the authors on the Shinkansen's rigid-frame bridges throughout the disaster area.

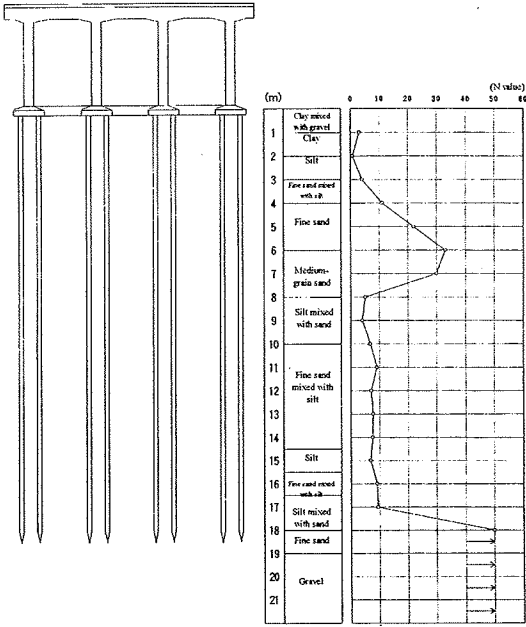
Fig. 5: Bridge A

Bridge A is a three-span (3m + 3 x 6m+3m) standard rigid-frame bridge (Fig. 5), with footings connected by underground link beams. It sustained no discernible outward damage by the earthquake. Bridge A had also been subjected to the dynamic percussion test (in 1991) prior to the earthquake.

Figure 5(b) is the Fourier amplitude spectrum of the response waveform measured after the earthquake. Comparing Figures 5(a) and 5(b), we can see that after the earthquake, the first natural frequency of the overall structure and the second natural frequency of the columns had declined by 0.4 Hz and 12 Hz, respectively.

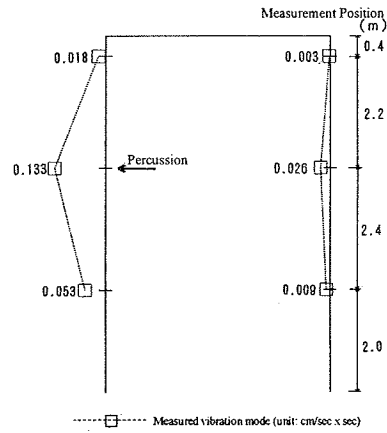
Fig. 5(c): Measured Vibration Mode of the Columns of Bridge A

Likewise, the peak at the right side of the Fourier amplitude spectrum is the second natural frequency of the columns. When the Fourier spectral amplitude corresponding to the frequency of this peak was used to draw a diagram of the column's vibration mode, the resultant modal form exhibited its maximum amplitude in the middle of the column, as shown in Fig. 5(c). Therefore, it was concluded that the peak on the right side of the Fourier spectrum is the second natural frequency of the column as shown in Fig. 4.

In addition, the phases of the left and right columns at this moment were synchronous (confirmed based on the phase-difference spectrum and the phase of the impact waveform). This finding confirmed that the columns' second vibration mode would assume a modal form like that shown in Fig. 4.

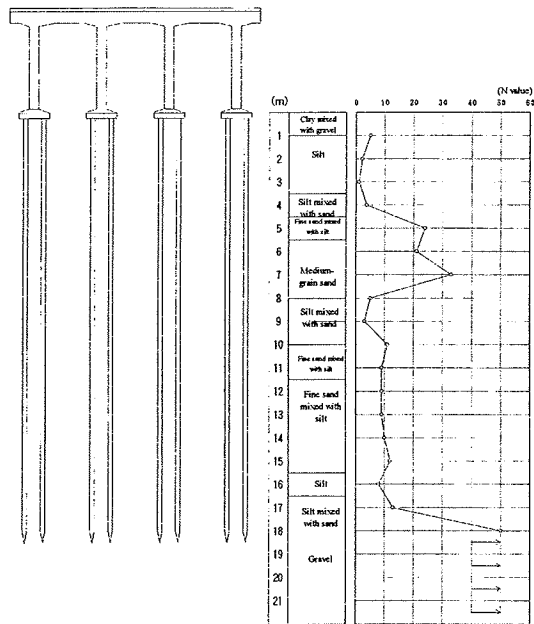
Fig. 6: Bridge B

Bridge B is a three-span (3m + 3 x 6m + 3m) standard rigid-frame bridge (Fig. 6) with isolated footings. After the earthquake, openings were found in the bottom section of its columns. These openings were subsequently filled with cement paste. We performed the dynamic percussion test before and after this repair work.

Figure 6(a) is the Fourier amplitude spectrum prior to the repair work, while 6(b) is the Fourier amplitude spectrum after the repair work. The natural frequency of the overall structure increased by 0.2 Hz following the repair work.
