FIELD INVESTIGATION OF DISASTERS IN SRI LANKAN RIVERS CAUSED BY
THE 2004 INDIAN OCEAN TSUNAMI

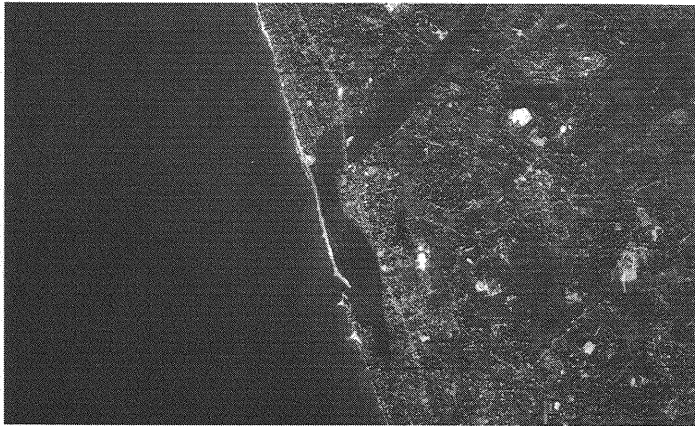
Photo 1 Satellite image before the tsunami at the Kalu River mouth (3)

The satellite images both before and during the tsunami at this river mouth were released by Hitachi Software Engineering Co., Ltd. (3), as seen in Photo 1 and Photo 2. The satellite images do not show any notable changes in the shape of the sand spit even after the tsunami hit, but the field investigation revealed signs of overtopping waves and resulting sediment movement as shown in Photo 3. However, the amount of sediment transported into the river mouth by the overflow was not so distinct, and the washout of vegetation was only partial as shown in Photo 3. In general, similar overtopping waves can be observed during storm waves, not only during tsunamis, and many investigations and studies have been previously carried out mainly in connection with breaching of barrier island due to storm waves (8). The geometric changes shown in Photo 3 are remarkably similar to those caused by overtopping of wind-generated waves reported in previous publications (8).

A bridge across the river is located approximately 2.5 km from the opening of the river mouth as seen in Photo 1. It was found that this bridge was entirely damage-free during the tsunami. As will be explained in detail later, notable

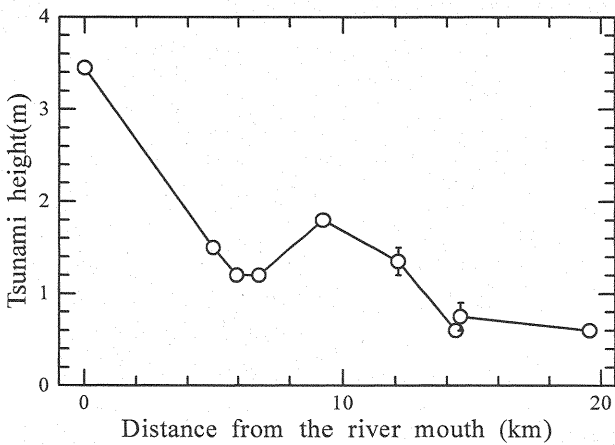
Fig. 2 Tsunami wave height along the Kalu River

The Kalu River sustained tsunami propagation up to distinct upstream distance because of its extremely gentle bottom slope, as aforementioned. Figure 2 shows the wave heights above mean water level along the river obtained from interviews to local people. There are many sand and gravel mining plants along the Kalu River, and several workers there witnessed the tsunami waves propagating upstream of the river. In the figure, the tsunami height at 0.0km denotes an observation in the coastal area (Koibuchi et al. (5)). It was observed that, once the tsunami entered the river mouth, its height reduced considerably. It is noted that a witness at the 12km point testified that a big wave was immediately followed by 3 to 4 smaller waves traveling up the river, suggesting formation of soliton fission in the river. At the uppermost point, no form of wave motion could be observed, only a slow rise and fall in the water level.

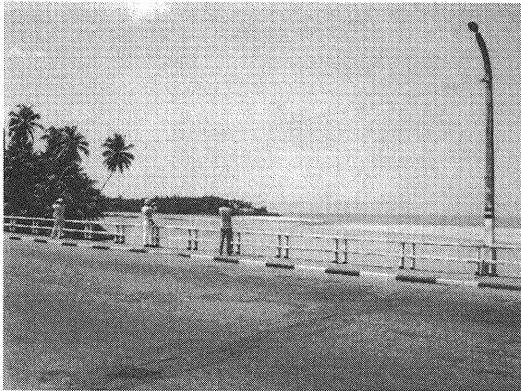
Photo 4 Sand bar at mouth of Gin River

Kalutara and Matara are cities located at the river mouth of the Kalu River and the Nilwara River respectively, but there is no city at the river mouth of the Gin River located between Galle, the capital of Galle District, and Hikkaduwa, Sri Lanka's largest seaside resort. The Gin River's catchment area is 947km^2 , and its length is 112 km. There is a sand spit of approximately 1.5km in length at the river mouth as shown in Photo 4, but is smaller and has a shallow water depth as compared to those at the Kalu River mouth and the Nilwara River mouth. The upstream region has a vast flood plain with dense vegetation on both sides of river banks, as shown in Photo 5.

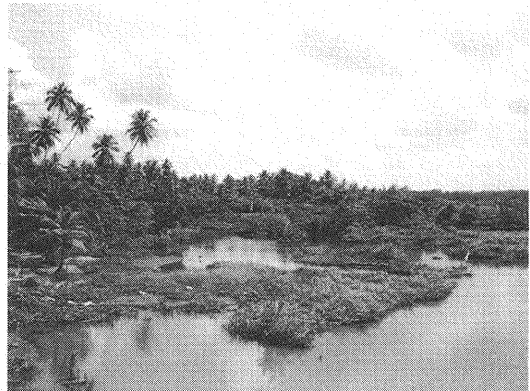
Photo 5 Flood plains in the upper mouth of Gin River

In summary, it was found that the tsunami energy in the Gin River dissipated sufficiently due to a vast shallow flood channel with dense vegetation at the river mouth.

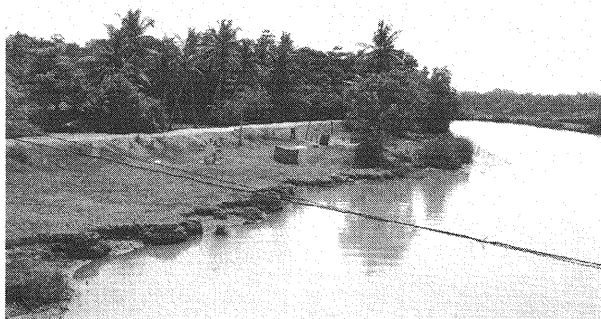
Photo 6 Levee 9km upstream from the river mouth of Nilwara River

A coconut farm exists 7km upstream from the river mouth on the right bank. It was reported that the water level rose up to 60cm above the river surface due to tsunami, but it did not cause any severe damage. At a bridge 9km upstream from the river mouth (Photo 6), there was no sighting of propagation of tsunami. Thus, it is likely that the existence of trees on both river banks and a vast flood plain weakened the energy of tsunami.

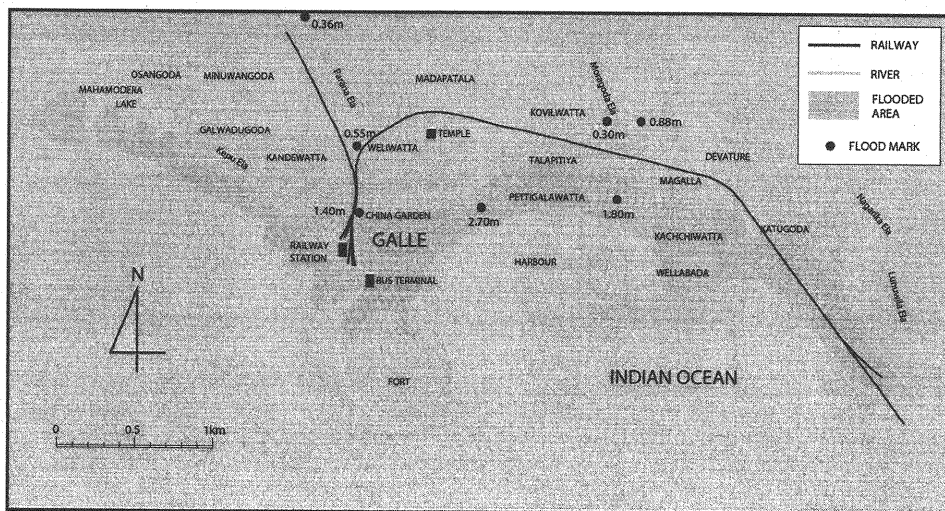
Fig. 3 Tsunami inundation area in Galle City

The first tsunami reached Galle District at 9:26am on December 26th 2004, and a second wave followed 20 minutes later (2). The second wave was larger than the first one, and as a result Galle City's coastal areas became submerged in water with 6m depth. Figure 3 shows the flooded areas within Galle City surveyed by Galle District Government, in addition to flooded depth data at several points (indicated by dots) obtained from the present field investigation. The damage from this tsunami was extensive with the death toll reaching 4,233 and the number of flood victims reaching 135,389. The damages caused by the tsunami are summarized in Table 2.

Flood depths were measured from the traces left by the tsunami along the Parana River that runs alongside the bus terminal in Galle City. The river width is about 12m near the bus terminal, about 8m near the China Garden, and about 3m near Weliwatta and these places are also shown in Fig. 3. The findings showed that tsunami flooding occurred even outside the flooded area surveyed by the Galle District Government. The tsunami surged up along the Parana River for approximately 2km upstream and caused flooding. Flood levels reached 30-90cm high which was also observed outside the flood region along Moragoda River. The tsunami propagated up this river for about 1km where the river width is around 10m, causing some localized flooding. Both rivers have rather narrow channel widths but have very mild bed slopes from each river mouth to 1 or 2 km upstream. These findings suggest that measures against tsunami penetration in small and mid-sized rivers running through rather flat areas should be considered seriously when contemplating anti-flood measures.

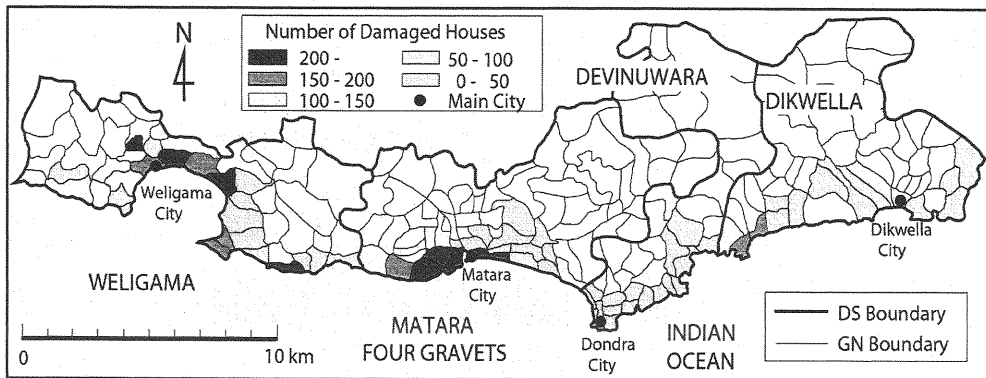
Fig. 4 Number of damaged houses in four Matara GN Divisions

Matara City is located approximately 160km south from Colombo. It is a city that has developed on the mouth of the Nilwara River with a population of roughly 65,000. Matara District was seriously hit by tsunami along most of its approximately 51km coastline. The damages were concentrated in the four regions facing the sea: Weligama, Matara, Devinuwara, and Dickwella. Each region is further divided into what is called GN Divisions. The number of damaged houses in these GN Divisions is shown in Fig. 4 (1). Although the number of damaged houses vary depending on the number of those which originally existed in the GN Division, many damaged houses were found particularly in the area facing the bay in Weligama District, and along the coasts of Matara City. In one of the GN Divisions in the Matara District, damaged houses were found not only along the coastal lines but also in the inlands as well. Since the Nilwara River runs through the GN Division, it was concluded that the tsunami penetrated the Nilwara River and caused local floods in the inner low-lying areas along the river.

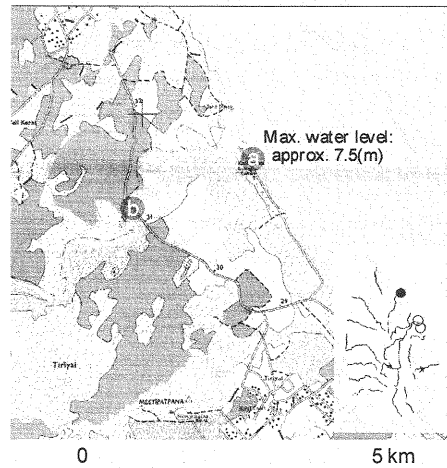
Fig. 5 Yan River estuary (point “b” is approximately 3.5km from river mouth.
The river banks in this stretch contain a thick mangrove)

It was revealed that the maximum tsunami height in the coastal area "a" shown in Fig. 5 was approximately 7m. Around the river mouth, on the contrary, the extent of damages was not so noticeable as compared with the coastal area facing the sea, although slight damages of vegetation and erosion and deposition of sediment could be seen. The reason for such a distinct difference of damages between coastal areas and the river mouth areas may be due to the fact that the coastline does not have any obstacles to reduce tsunami wave energy, whereas the tsunami waves remarkably dissipated their energy in the river due to its shallow water depth.

According to local residents, the tsunami height at the point "b" in Fig. 5, located 3.5km upstream from the river mouth was about 0.5m. In addition, they reported that the river bed elevation rose by roughly 4m in some places. Judging from the maximum tsunami water level in the coastal area and the ground elevation at this point "b", the rise in the water level due to tsunami was too small there. This was probably due to dense mangrove forest and extremely shallow water depth at the river mouth, which contributed greatly to suppressing the distance of tsunami penetration. Nevertheless, there is insufficient information to fully explain these processes at the present. Furthermore, there may be other factors which caused tsunami energy dissipation in the study area. Future investigations must be carried out regarding effects of vegetation and river mouth topography on the tsunami penetration.

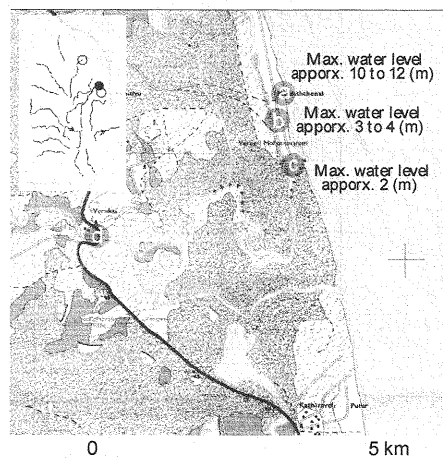
Fig. 6 Mahaweli River estuary (Distance between point “c” and “d” is approximately 3.2 km)

A village by the name of Mudduchchenal existed in the area near the river mouth marked "a", "b" in Fig. 6, but was completely destroyed by this tsunami and is currently deserted. The maximum tsunami water depth in the palm tree zone "a" along the coast was about 10-12m judging from bending of palm trees. The average tsunami height along the roadside trees in the village "b" was about 3-4m, whereas the maximum water depth on the land areas along the river channel indicated "c" in Fig. 6 was about 2m. Thus, distinct difference of water depth was observed between the two locations. The reason for this is that the water depth on the side of incoming tsunami flood water rose drastically at "b" due to the effects of roadside trees and structures in the village, while the region "c" along the river channel had relatively fewer obstacles to intercept the tsunami height, resulting in lower tsunami height.

An investigation into the sediment deposit was also carried out in the river bank near "c" in Fig. 6. Local scouring of river banks generated by the return flow was found near the river channel, and sediment deposit of about 0.3m thick was found at 50m inland from the river bank. Both, however, were in their terminal stage, and their formation process is unknown.

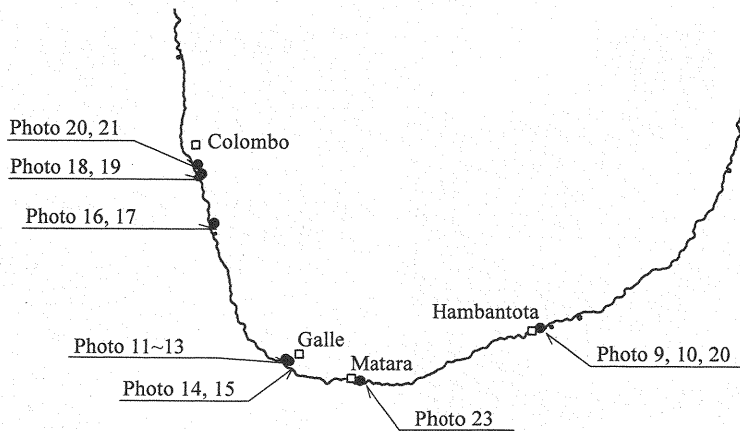
Fig. 7 Location of investigated bridges

Furthermore, investigations were carried out on five bridges, which apparently had not sustained any significant damage. Figure 7 denotes the location of the bridges expressed in terms of photo number shown hereafter.

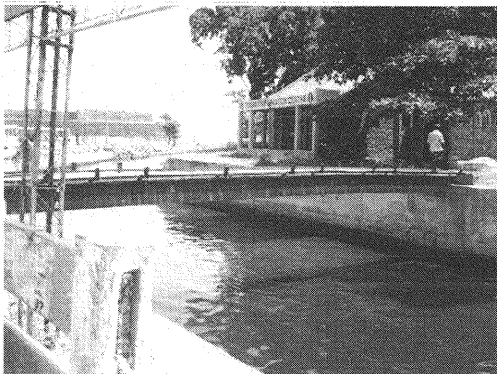
Photo 11 Pedestrian bridge in Galle remains without being washed out

Another pedestrian bridge in Galle (span length=13.9m, width=0.75m and thickness=0.8m), shown in Photo 11 whose width is narrower than the above-mentioned sidewalk bridge but which remained without being washed away was investigated. Since both ends of this bridge are clamped firmly to the base, it did not move due to the drag force induced by the tsunami. However, all the handrails of this pedestrian bridge were broken and washed away as shown in the photograph.

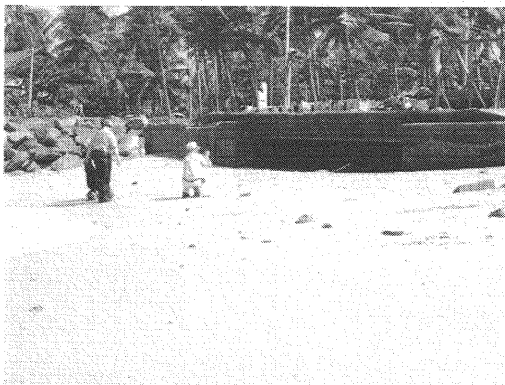
Photo 14 Undamaged sea-side bridge

Seaside of the 8.3m long bridge that handles one way traffic left undamaged by the tsunami is shown in Photo 14. The damaged sustained to landside is clearly visible in Photo 15. This bridge is located in a beach shore protection area. The left bank side was destroyed and the river bed around the bridge was eroded.

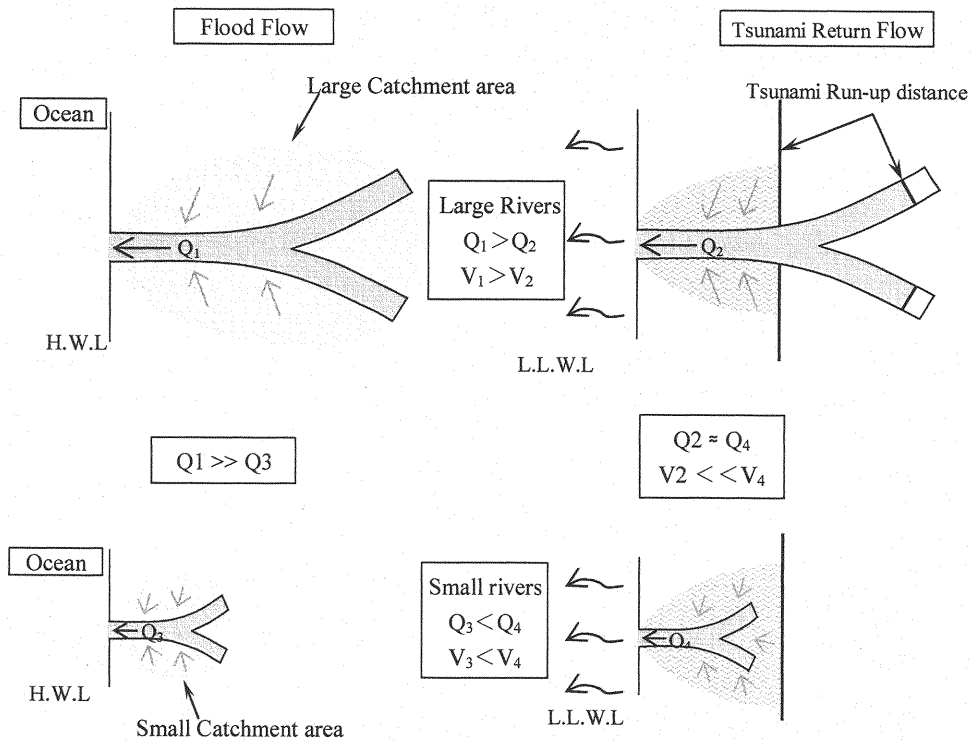
Fig. 8 Comparison concept chart of flood and tsunami flow at catchment areas of large and small rivers

size of the river: $Q_2=Q_4$. The water mass which travels up along the land and the river channel with the tsunami wave returns to the sea mainly via the rivers. The return discharge of the tsunami wave Q_2 is less than that of a flood Q_1 in the large rivers. However, the return flow discharge of the tsunami wave Q_4 increases more than the flood discharge (Q_3) in small rivers. Therefore, due to tsunami waves, the damage sustained by a bridge of a large river is relatively small compared to the damage sustained by a bridge of small rivers.

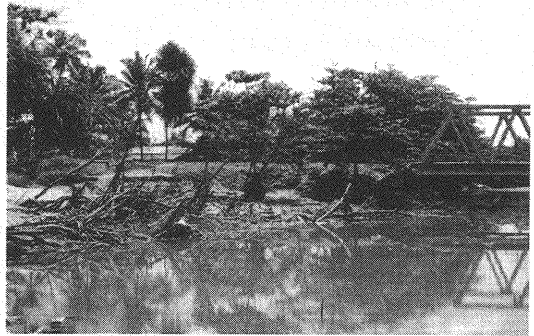
Photo 19 Undamaged truss railway bridge in the upstream of bridge in Photo 18

Photo 19 depicts the circumstances of the vegetation around another truss railway bridge which is about 75m upstream of the bridge in Photo 18. As shown in the photograph, the vegetation on the banks of the river are torn apart and pushed towards land side, indicating clearly the velocity of the tsunami wave as well as its returning flow.

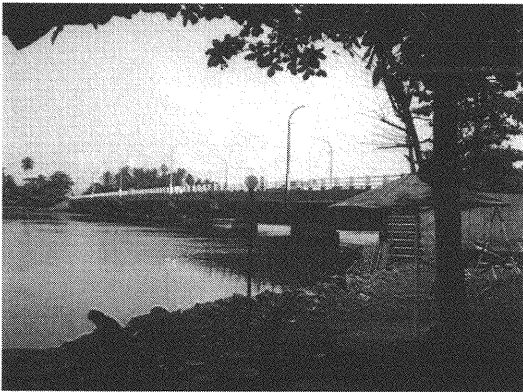
Photo 20 A road bridge across the Panadure River

In Photo 20 a relatively large bridge of 205m in length, and height of 3.0m from the water surface to the girder is shown. The damaged situation of the left bank protection located just downstream of this bridge is shown in Photo 21. Because of the greater height between the bridge bottom and water surface in large rivers the tsunami wave did not reach the girder, hence there was no apparent damage to the girder and to the hand rails. However, the damages to the bridge approach are observed in many places.

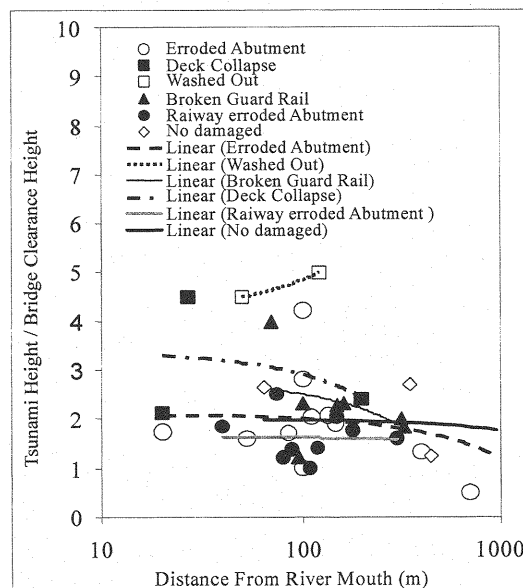
Fig. 9 Relations between distance from river mouth and ratio between bridge clearance heights to tsunami wave height

In Fig. 9, the relationship between "ratios of travel upstream height of the tsunami wave/clearance height of the bridge" and "distance from the river mouth to the bridge" is shown. As observed in the figure, extent of the damage increases with the ratio. In addition, it is clearly seen in the graph that when the bridge is located near by coastline, the damage becomes severe (girder washed out and deck collapsed). The relationship between the ratio of tsunami wave height to bridge clearance height and length of the bridge is shown in Fig. 10. This finding shows that damage is greater where the bridge span is shorter.

Figures 9 and 10 clearly indicate that the damage become more severe (girder washed out and deck collapsed) as "ratio of tsunami height/bridge clearance height" exceeds 2.0. Moreover, it can be concluded that severity of the damages diminishes when the bridge span is longer than 30 m and distance from the river mouth are longer than 200m. Therefore, it is possible to estimate roughly damages that bridges might sustain by a tsunami wave in the future.
