AN INVESTIGATION ON FATIGUE STRENGTH FOR TRANSVERSE CHORD OF STIFFENING TRUSS

By Kenji SAKAMOTO*, Masahiko YASUDA*, Makoto FUKAZAWA** and Chitoshi MIKI***

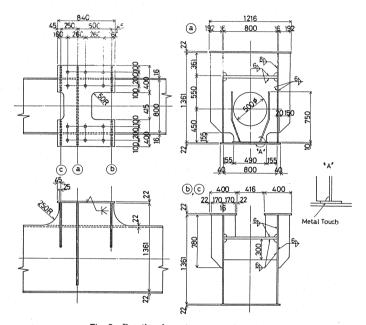
Fig. 3 Details of section supporting stringer.

Details of the section supporting the stringer are characteristic as shown in Fig. 3. In the fatigue design code for Honshu-Shikoku Bridge²⁾, details are grouped in 4 categories from A to D according to the fatigue strengths of details, where Category A is the highest. In the original design of this transverse chord, various welding details of top flange (compression-side) were all Category C and these of bottom flange (tension-side) were Category A. The

With these details it is expected that the torsion, due to the support reaction at the stringer, induces out-of-plane distortion of the web plate at the scallop of the diaphragm. This out-of-plane distortion may cause cracks at

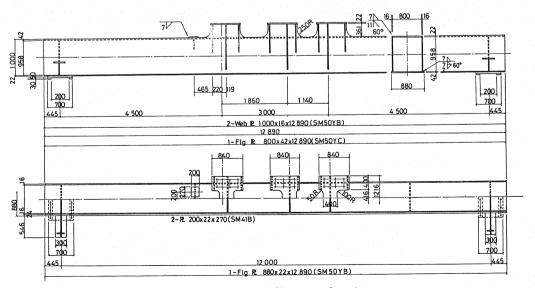
Fig. 5 Configuration and dimensions of specimen.

The configuration and dimensions of the specimen are shown in Fig. 5 To aid the bending fatigue test, the thickness of the top flanege and location of the stringer support were partially different from those of the actual member. In order to obtain the same stress conditions of the flange of the specimen under bending test, as these of the transverse chord in actual structure, the top flange plate was thickened from 22mm to 42mm. The specimen was constructed with structural steel of JIS G 3106, the flange and web plates of
