WELD REPAIR OF CRACKED BEAMS AND RESIDUAL FATIGUE LIFE

By Kentaro YAMADA, Yoshinaga SAKAI**, Akimasa KONDO***
 and Yoichi KIKUCHI*****

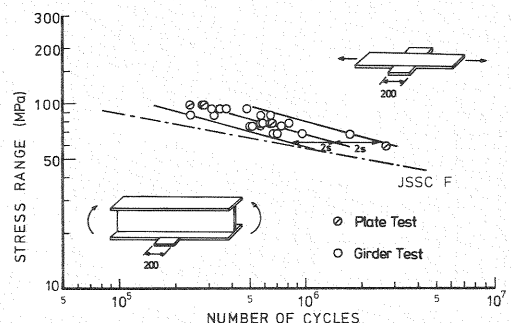
Fig. 3 Fatigue test results of beams with groove welded gussets of 200 mm long (G).

G-type Gussets : Fatigue test results of 200 mm long gussets welded to tension flanges are plotted in Fig. 3. Also plotted are the fatigue test data of tensile plates of 200 mm wide with the as-welded gussets of 200 mm long³⁾. The mean $S-N$ diagram and the standard deviation, s , were computed from total of 26 data, as follows.

The mean $S-N$ diagram and the confidence limits plotted two standard deviations away from the mean are shown by solid lines in Fig. 3.

test data seems to satisfy the allowable stress range, as shown in Fig. 3.

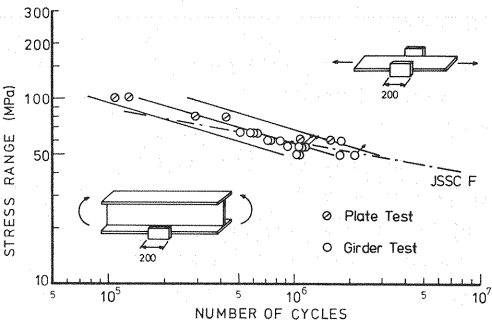
Fig.4 Fatigue test results of beams with fillet welded gussets of 200 mm long (T).

T-type Gussets : Fatigue test results of 200 mm gussets welded transversely to tension flange are plotted in Fig. 4. Also plotted the test data previously obtained for the same type of gussets welded to tensile plates³⁾. The mean *S-N* diagram and the confidence limits are also plotted in Fig. 4. They are determined from total of 19 data, as follows.

The stress concentration factor at the end of the T-type gusset is higher than that of the G-type gussets, when the length of the gussets is the same³⁾. Therefore, fatigue strength of T-type gusset is lower than that of G-type gusset. The detail is not specified in the JSSC recommendation for fatigue design. If one applies the detail class F for this detail, some data fails to satisfy the allowable stress range, as shown in Fig. 4. It implies that the allowable stress range of this detail ought to be lowered to, for example, detail class G.

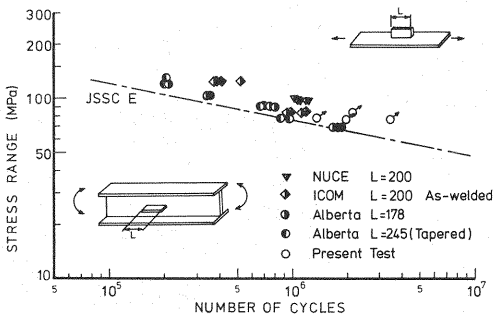
Fig.5 Fatigue test results of a beam with gussets welded to web (GW).

GW-type Gussets : No fatigue cracking was observed at the end of the gussets welded to the web, even after the additional fatigue tests which were carried out after weld repair. The runout data is plotted with an arrow in Fig. 5, along with the previous test data of the same type of details⁵⁾. The present test data seems to show longer fatigue life compared with the previous test data. This may be due to the good weld toe shape which is favorable to fatigue resistance. The data satisfy the allowable stress range of detail class E of the JSSC recommendation for fatigue design.

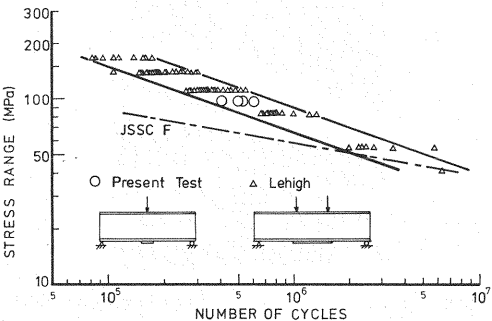
Fig.6 Fatigue test results of beams with a welded cover plate of 400 mm long.

Cover Plate : The as-welded cover plate showed four independent fatigue crackings at the toes of the end fillet welds perpendicular to the applied stresses. The cracks propagated into the flange plate and then to the web. The test data is plotted in Fig. 6 with the test data generated at Lehigh University⁶⁾. The cover plate in the present test was 400 mm long and it showed an equivalent fatigue life as the Lehigh data, provided that the cover plate length of Lehigh data was over 1 000 mm. The detail is classified into detail class F according to the JSSC recommendation for fatigue design. The data satisfied the allowable stress range, as shown in Fig. 6.

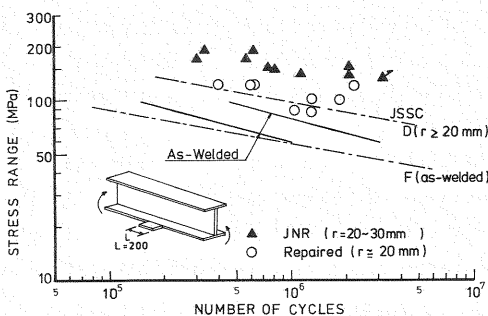
Fig. 11 Fatigue test results of beams with gussets of 200 mm long (G) after weld repair.

Fatigue test results of G-type gussets are plotted in Fig. 11. All test data was found to have longer fatigue life than the as-welded ones shown by a confidence interval. It may be because the ends of the gussets were ground to the radius of about 20 mm which eliminated high stress concentration at the weld toes. It implies that the weld defects observed in the repair welds were less harmful than the stress concentration at the weld toes of the gusset ends. Therefore, the repair welds described here are acceptable to repair fatigue crack and to prolong the fatigue life.

The JSSC recommendation for fatigue design classifies the ground ends of over 20 mm radius into detail class D⁰. When repair weld is not subjected to an appropriate non-destructive testing, the fatigue life may not satisfy this allowable stress range. In these cases, it may be safe to lower the allowable stress range of the repair weld, for example, to the detail class F for the as-welded gussets.

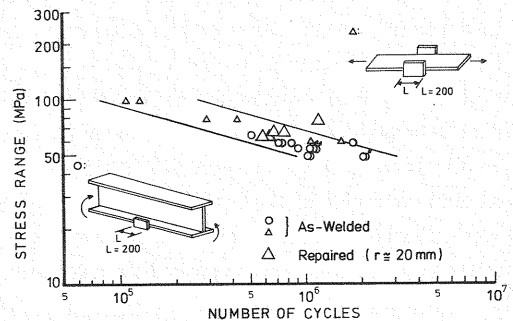
Fig. 12 Fatigue test results of beams with gussets of 200 mm long (T) after weld repair.

Fatigue test results of the T-type gussets with repair welds are plotted in Fig. 12, where the as-welded data is indicated by two solid lines corresponding to the confidence interval. The present test data of the repair welds showed approximately the same fatigue life as the as-welded gussets, even though the gusset ends were ground.

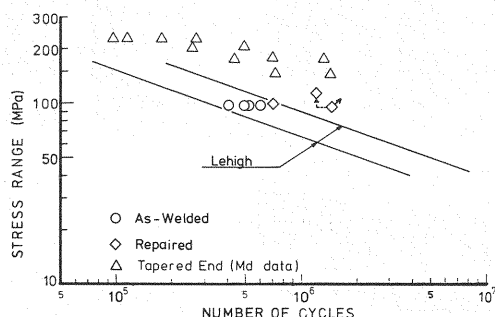
Fig. 13 Fatigue test results of cover plates after weld repair.

Fatigue test results of the cover plates after repair weld are plotted in Fig. 13. Also plotted are the confidence interval of the as-welded cover plates tested at Lehigh University⁶⁾ and the test data of the cover plated beams with tapered end welds tested at University of Maryland⁸⁾. The data of the repair weld showed an equivalent or longer fatigue life compared to the as-welded ones, owing to the ground end welds. Especially one side of the cover plate resisted 1.44 million cycles of loading, and additional 1.16 million cycles of higher loading before fatigue cracking was observed at the plug weld of the stopholes. It implies that the present weld repair procedure was satisfactory to repair cracks from the cover plate ends. The
