FATIGUE STRENGTH OF WEATHERED AND DETERIORATED RIVETED PLATE-GIRDER

In this study, a detailed review of the fatigue test results of riveted joints which have been performed in Japan, is conducted. A fatigue test is carried out on a plate-girder bridge which has been used in a railroad about 70 years. The fatigue strength and the initiation and propagation behavior of fatigue cracks of weathered and deteriorated riveted plate girder is discussed.

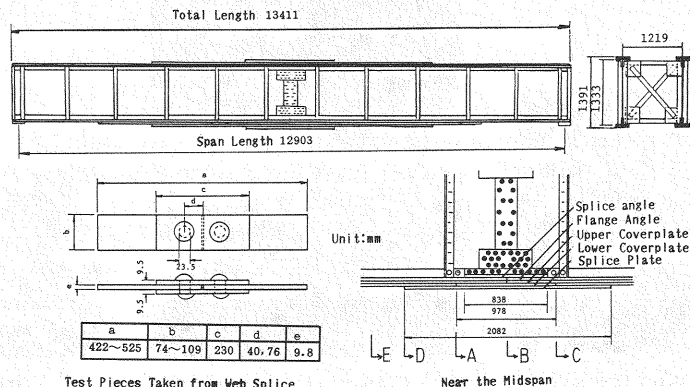
Fig. 4 Specimen.

A riveted deck plate girder (Fig. 4) of a JNR bridge spanning the river Kannagawa on the border of Saitama and Gunma prefectures was tested. Stress measurements of this bridge under train loading were performed by Abe et. al.¹²⁾ The maximum measured stress by the passage of old steam locomotive is about 45 MPa. Therefore, the cumulative fatigue damage in service may be negligible. The steel employed was "S 39", which is approximately equivalent to SS 41. This bridge with a span length of 12.9 m was constructed of two I-section girders each 1.391 m deep. The largest sections (E-E sections) of these girders had the flanges composed of two angles and two cover-plates. Rivet splices were connected at the midspan; webs, flange angles and upper cover-plates were connected at the midspan; and lower cover-plates were connected at two sections located at 0.49 m from the midspan. Rivets were not loosened. Tension flanges, except near the supporting point and partially at flange angles, were found relatively sound with little reduction of sectional area due to corrosion. On the surface of compression flange upon which there was no tie the corrosion had advanced; particularly a heavy reduction of sectional area was recognized at the boundary with splice plates.

After fatigue tests of this girder, small test pieces of riveted joints were taken, as indicated in Fig. 4, from the web splice.

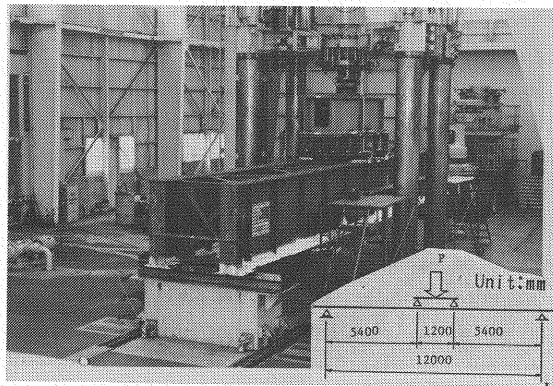
Fig. 5 Fatigue Testing Set-up.

minute with sine load waves ranging from 49 kN to 1470 kN. Fig. 5 shows the testing set-up. In this test the stress range was halved with the minimum stress stepped up for each specific number of cycles so that beach marks could be left on the failure surface. After the test, the girder was broken up with the rivets removed in order to check for potential cracks which were not found during the test. First, visual examination and magnetic inspection were done to check for cracks in rivet holes. When cracks did not observed, a penetration test followed. Most of the potential cracks were observed by these detailed inspection. The joint specimens cut out of the web were submitted to fatigue testing at stress ratio 0.

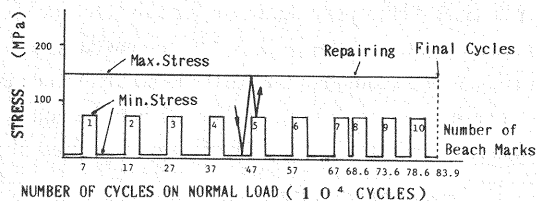
Fig. 6 Loading History.

Fig. 6 illustrates the loading history. At about 10^4 cycles a crack (L_A crack) initiated near the edge of a corroded groove of the horizontal angle leg (reduction of sectional area was about a half that of the original shape) at the end of the splice angle in the vicinity of A-A section of the left girder. Photo 1 shows the ultimate state of this crack. This crack was observed to coalesce into new ones which developed later.

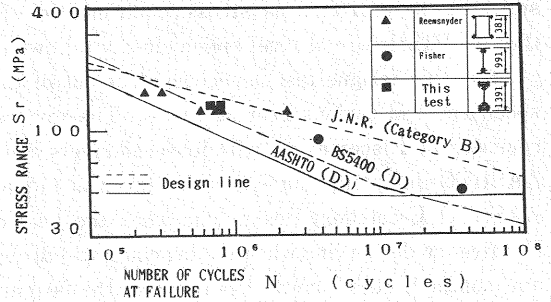
Fig. 7 Test Results of Riveted Members.

The relationships between number of cycles to failure and stress range of riveted details in this test is illustrated in Fig. 7, in which the number of cycles to halve the stress range for the purpose of leaving beach marks on the failure surface is not included. For the comparison, the design life curves for riveted joints in JNR, AASHTO and BS 5400 specifications and other fatigue test results of large size riveted member are also given. The results of this test are close to the other results of riveted members; and these results approximately match the lower bound of fatigue test results of small test specimens in Fig. 3. The results of riveted members come below JNR design life curve; and below the BS 5400 one in a high stress range region. In the tests of aged and deteriorated stringers undertaken by Fisher et al., fatigue cracks initiated from rivet holes in the equi-moment section with no rivet splice and the stress condition at rivet

splice was severer than the stress condition at riveted detail with no rivet splice. From this fact, it seems that the fatigue life of rivet splice closely follows the AASHTO design life curve for D-category joints.

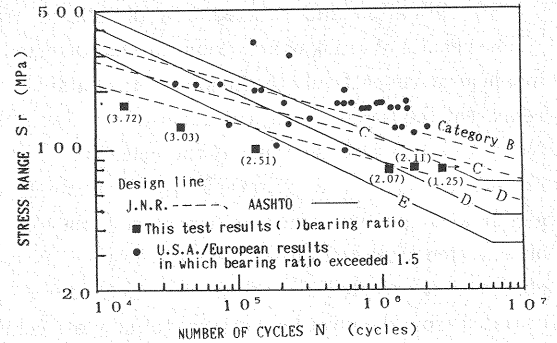
Fig. 8 Test Results with Bearing Ratio Varied.

After this fatigue test, specimens cut out of the web splice were submitted to fatigue tests. These specimens had various bearing ratios. The test results were illustrated in Fig. 8. The results of test reviewed by Fisher et al. with loosened rivets and the bearing ratio amounting to more than 1.5 and the AASHTO design life lines are also given in Fig. 8. The results of this fatigue test are lower than the AASHTO E-category design line when the bearing ratio exceeded 2.5, and barely equivalent to the D-category design line when the bearing ratio dropped to about 2. The rivets of these test specimens are not loosened. It is known from this that the fatigue strength considerably decreases as the bearing ratio increases.
