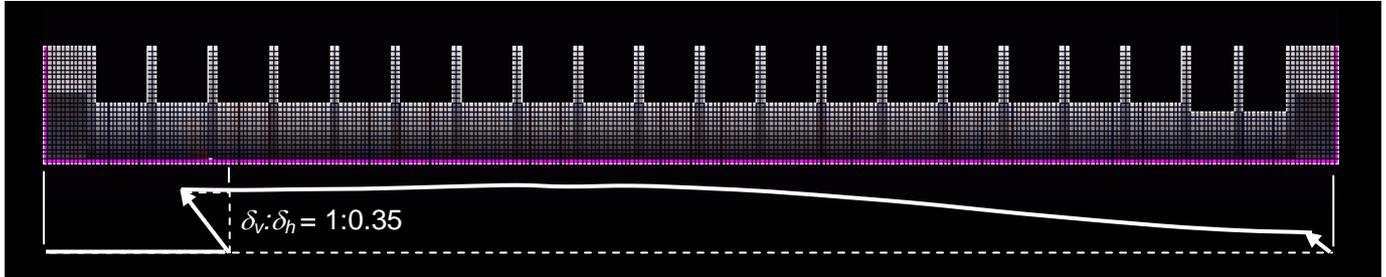
Fig. 4 AEM mesh and input deformation

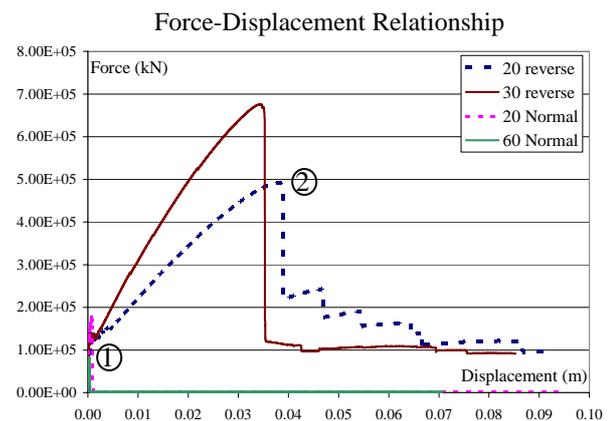
Fig. 6 Effect of dip angle on Force-Displacement relationship

As shown in fig. 6, the behavior of the dam under reverse and normal fault is totally different. For the normal fault, the dam will be suddenly broken into two pieces after stress in concrete reach its tensile strength. As a result, it is thought that the normal fault is more dangerous in case that fault movement is occurred. The change in dip angle of reverse fault slightly increases resisting force after separation of the dam from the bed rock. This is due to difference in the compressive stress in the dam. For the normal fault, larger dip angle results in decreasing maximum resisting force but the affect is very small.

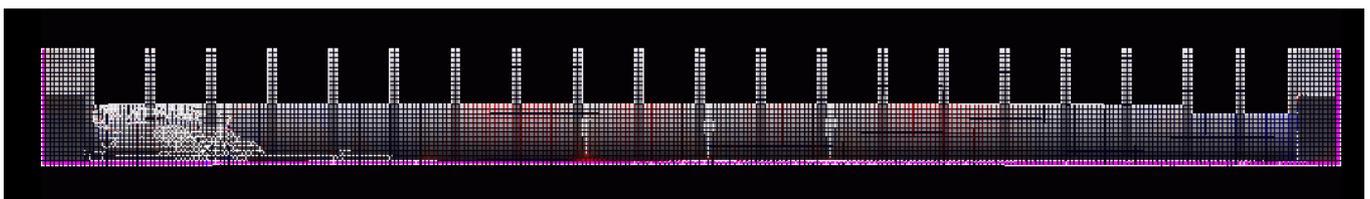
Fig. 7 Crack distribution on the whole dam after applying fault induced ground rupture and deformation

As the deformation increases, the cohesion between dam and bed rock start deteriorating. Later, the tension cracks, resulted from bending effect due to the curve deformation of the ground surface, were observed (Fig. 7). Those cracks propagate very fast from the top to the bottom after its initial appearance because no reinforcement is provided. It is worth noting that although the movement just above the fault stated in previous section has higher displacement magnitude, the fault-induced ground deformation has higher possibility to hit the structures due to its wider effective area. Therefore, this deformation should be carefully considered in the dam designing process.
