# Fatigue cracking behavior of a through-thickness crack under out-of-plane bending

Nagoya University ○Xiao-Chen JU, Kazuo TATEISHI and Sung-Min CHOI

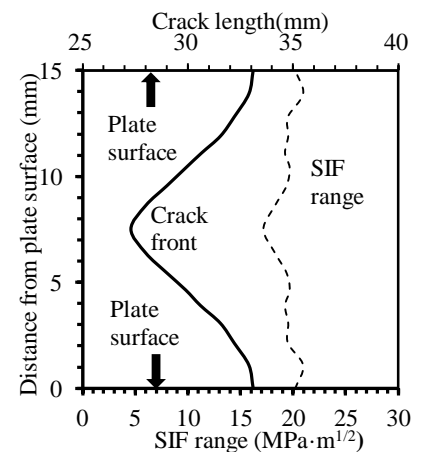
Fig. 7 SIF range along V shape crack front

Since SIF is an important factor to identify the crack propagation behavior, the SIF distributions along the crack front were investigated. Mode I SIF was calculated by J-integral method. Fig. 6 shows the SIF distributions along the crack front for different crack lengths. Regardless of the crack length, SIFs in the tensile region are roughly uniform, decline drastically around the interface of tensile compressive sides, and eventually become zero at the compressive side. Since the stress ratio is -1, a symmetric distribution must be presented when inversed loading is applied. As an example, Fig.7 represents the SIF range ( $K_{\max}$ - $K_{\min}$ ) when crack length at plate surface is 33.1mm. In the graph, the dotted line is calculated SIF ranges, and the solid line indicates crack front. As shown in the figure, the SIF ranges remain approximately uniform along the V-shaped crack front.
