Investigation of the shear buckling strength of the web panel with local corrosion

Kyushu University Regular member ○J. H. Ahn
 Kyushu University Regular member _S. Kainuma
 Kyushu University Student member _Y. S. Jeong

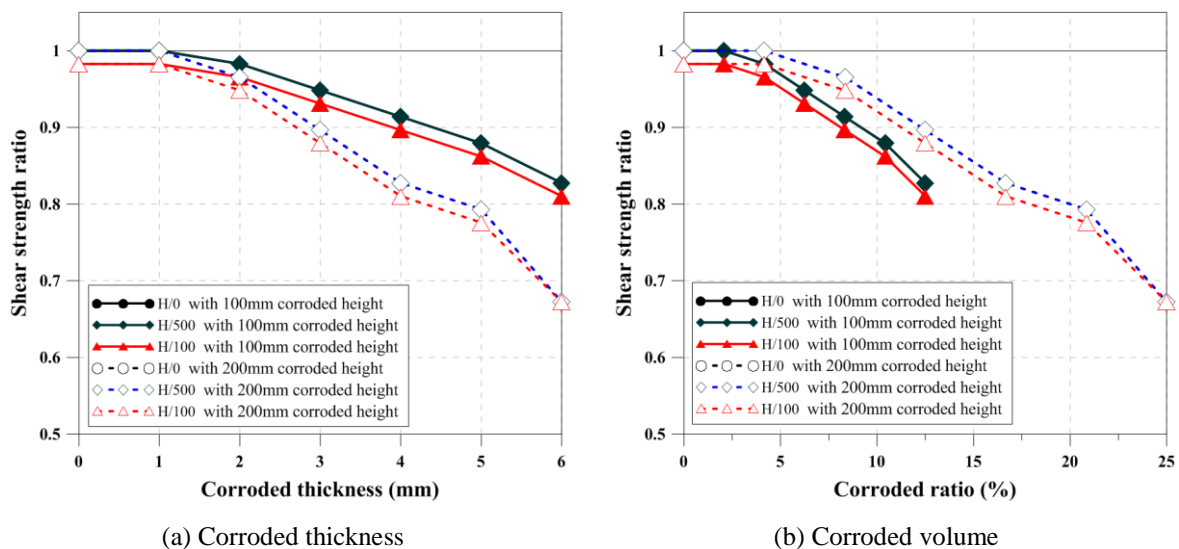
Fig.4 Relationship between shear buckling strength ratio and Corroded condition

From the FE analysis results, shear buckling strengths of the web panel with local corrosion were summarized by varying the corroded web thickness and corroded volume in Table 1 and Fig. 4. From the Table 1, the shear buckling strengths of web panels with 100 corroded web height was steadily decreased to 81% of the uncorroded web panel. For web panels with 200 corroded web height, their shear buckling strengths were steadily decreased to 67% according to corroded thickness and volume ratio. In the H/100 cases, the shear buckling strengths were slightly decreased than the other imperfection cases.

4. Summary of findings In this study, the shear buckling strength of the web panel with local corrosion was numerically examined to quantitatively evaluate the change in the shear buckling strength according to corroded condition. From this numerical evolution for the shear buckling strength of the web panel, shear buckling strengths were decreased according to the corroded height and corroded volume. For corroded height of the web panel, the shear buckling strengths ratio were shown to be sharply decreased in the lower corroded height.
