## Investigation on the bond behavior between different cleaned steel surfaces and carbon fiber sheets

Kyushu University Student member  
Kyushu University Fellow member

○Weijie LIU  
Shigenobu KAINUMA

Kyushu University Regular member Muye YANG  
Kyushu University Student member Jiajing XIE

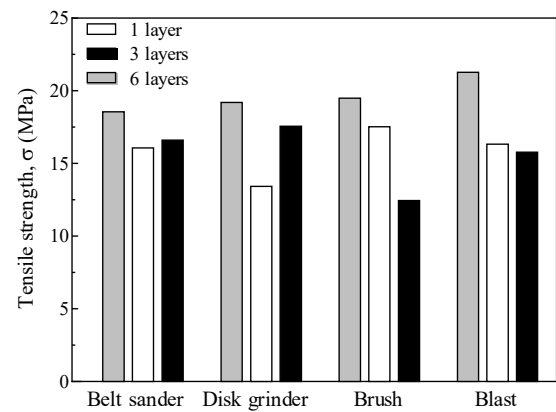
Fig.3 Adhesive strength of one, three, and six-layer CFRP attached to steel plate

**3. Results and discussion** The roughness parameters  $R_a$ ,  $R_{zjs}$ ,  $R_{Sm}$  measured by LSCM and contact-type tester in Table 1 show a tendency of  $BS < DG < Brush < Blast$ . There is no significant difference between the two methods. Using 3D laser microscope to evaluate the surface roughness is proper for its measuring mechanism. As each parameter can only represent a single aspect of the surface roughness, they cannot be used to assess adhesion individually. The actual surface area was adequately expressed by a Wenzel roughness factor<sup>2)</sup>. An increase in surface area may well lead to a proportionate increase in adhesion. The pull-off test results of steel surface as shown in Fig.2, that the bond strength of the four types of clean steel surfaces shows  $Brush < BS \approx DG < Blast$ , while the true surface area of Blast in the same projected area is much larger than three other cases. The pull-off test results of the multi-layers group are illustrated in Fig.3. Herein, all test failure modes are CFRP delamination. Therefore, regardless of the steel surface, the tensile strength only depends on the bond strength of the adhesive in CFRP. However, the tensile strength of three and six layers is lower than that of one layer. It can be speculated that thicker carbon fiber sheets may be less likely to be totally impregnated by adhesive, so thicker composite materials may be more tent to be fracture failure. Fig.4 shows the results of aging specimens after the wet-dry cycle and immersion of 10 days, respectively. Comparing with the unaged cases, the bond strength reduction of specimens exposed in immersion environment was more evident than that of wet-dry group. Different steel surface cleaning methods would also affect the deterioration of CFRP, that the Blast cases show a minimum drop ratio of adhesive strength in both wet-dry and immersion groups. Moreover, three kinds of failure modes, which include (a) CFRP/dolly-adhesive interfacial debonding, (b) CFRP delamination, and (c) steel/adhesive interfacial debonding, were observed. Fig.5 depicted the typical failure modes for the specimens of the unaged, wet-dry and immersion group, respectively. Failure (a) and (b) were mainly observed from the unaged group and immersion group, while failure (b) and (c) was mainly observed from the wet-dry group. It can be speculated that failure mode (b) occurs due to the CFRP delamination, and the moisture penetration facilitated this damage due to the epoxy deterioration. Failure (c) happened in wet-dry group, not only caused by the moisture penetration but also due to the corrosion of steel base and thermal deformation difference at the interface. The wet-dry cyclic exposure would lead to steel/adhesive interfacial debonding.
