HYDRAULIC UPLIFT PREVENTION BY CUT-OFF WALL: A CASE STUDY ON LARGE EXCAVATION IN CENTRAL JAKARTA

1. INTRODUCTION

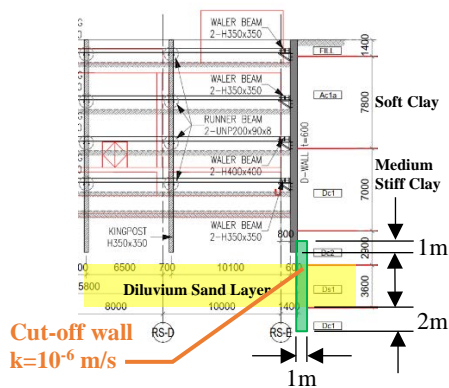
Figure 4 Design configuration of cut-off wall.

Due to the contract requirement which prohibits active pumping, installation of water cut-off wall and pressure relief wells was chosen as countermeasure against the hydraulic uplift failure. Based on flow analysis result, minimum 1m thick cut-off wall (coefficient of permeability, $k = 10^{-6}$ m/s) with 1m overlap into D-wall toe and 2m embedded into impermeable layer was required to prevent the uplift failure and excessive settlement due to groundwater drawdown. Pressure relief wells with minimum total flow capacity of 900 litre/min was required according to the estimate flow capacity of the walls from flow analysis result. **Figure 4** shows the design configuration of cut-off wall. The result of flow analysis by 2D FEM is illustrated in **Figure 5**.
