ESTIMATION OF FATIGUE CRACK GROWTH BY ULTRASONIC IMAGING METHOD

By Kenji SAKAMOTO*, Makoto FUKAZAWA**,
Masayoshi HAMANO*** and Jiro TAJIMA****

For a partially penetrated corner joint, estimations of the fatigue crack size and the crack growth behavior are investigated using the ultrasonic imaging method. Experimental results are obtained as follows :

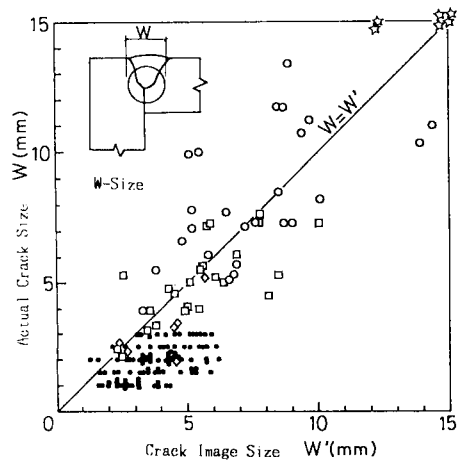
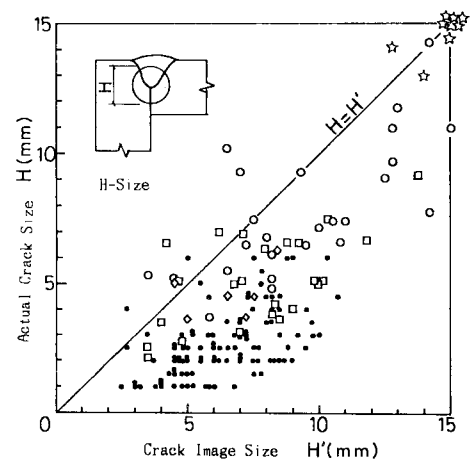
Fig.6 Relation between crack size and image size.

Fig. 6 shows the relationship between fatigue crack and ultrasonic defect image according to each size of W and H . The black mark is a blowhole which does not generate a fatigue crack, and cracks are classified by the marks shown in Fig. 5 which signify the stages of crack growth.

These relationships show that the ultrasonic defect image size gets larger as the fatigue crack grows. With some dispersal, the relationship of the crack image is equivalent to the actual crack with regard to W size, but the image has a tendency to become larger than the actual crack size with regard to H size.

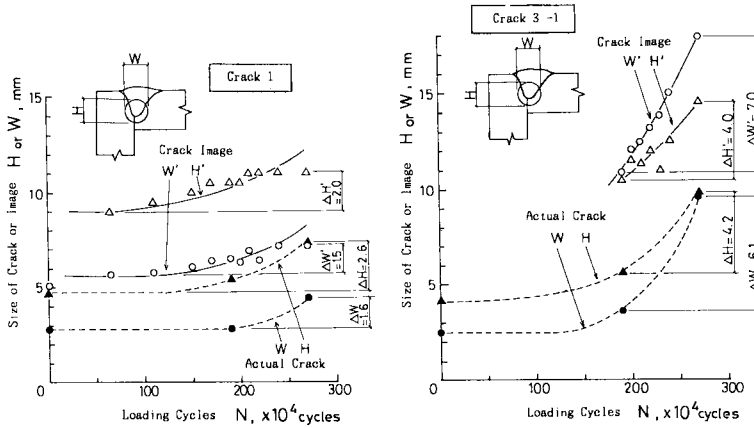
Fig. 18 Development of crack and ultrasonic image.

In the two cracks, the variation of actual crack size and ultrasonic image size due to increase of load cycles was plotted in Fig. 18. The characteristic of Fig. 18 are very similar to box section type specimen. Trend line of ultrasonic crack image is shifted above that of actual crack size in

a load cycle and both degrees of size increase are also similar. When the extent of the size increase of crack image is calculated using image size before fatigue test and 190×10^4 cycles as an initial number, size of crack image almost corresponds with that of actual crack.

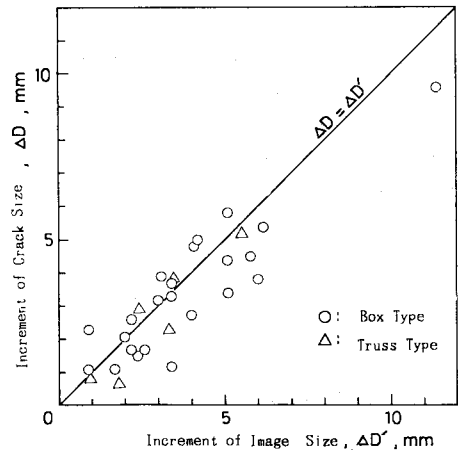
Fig. 19 Relation between variation in crack size and crack image size.

Fig. 19 shows the relationship between the variation in the actual crack sizes and the crack image sizes, including the test result of the box-section specimen. As an initial value, the size at the repeated cycles of 190×10^4 , when the cracks grew remarkably, was adopted for the truss panel-pointed specimen, and the size at the repeated cycles of 30×10^4 (in the initial testing) was adopted for the box section specimen. In all cases, it is observed that the variations are distributed on both sides of the following line and represent close correlation between the two.

$$\Delta D = \Delta D' \dots\dots\dots (2)$$
