# River response by sediment transport after dam slit in mountain stream

Jihyun KANG  
So KAZAMA

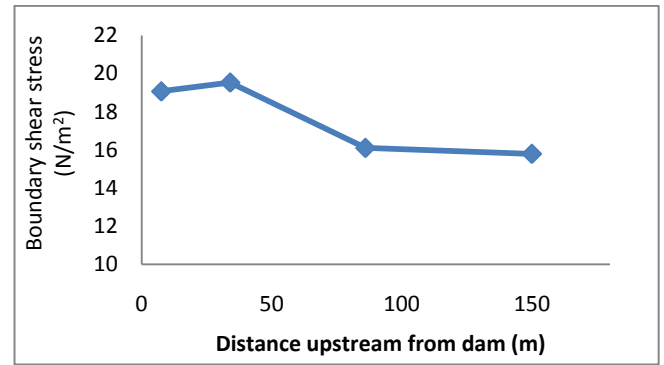
**Figure 3. Boundary shear stress at four cross-sections of 7.5m, 34m, 86m and 150m distance from dam**

Erosion and deposition are an important and basic mechanism for river response. We calculated tractive force using shear stress (2.1) at 4 cross-sections which are 7.5m, 34m, 86m and 145m distance from dam in upstream reach of dam.

Boundary shear stress shows a tendency to decrease when the distance from dam is far (figure 3). The shear stress calculated for a flow of  $2.5\text{m}^3/\text{s}$  is highest as  $19.53\text{ N/m}^2$  at cross-section of 34 m distance from dam. It means that a tractive force is sufficient to erode either fine, cohesive sediment ( $\tau_{\text{crit}}=8\text{ N/m}^2$ ; Chow(1959), Doyle(2003)). In addition, unconsolidated sediment still remains on the stream bottom and both banks. The banks are exposed to erode because the slope is fresh without vegetation cover. Therefore, dynamic river response will be happened by high discharge of either snow melt, rainy season.
