# Practical Application of a Road Pavement Condition Assessment System to the Mine Road Network in Yamaguchi

## 2. Outline of Proposed System (Ippo-Campo)

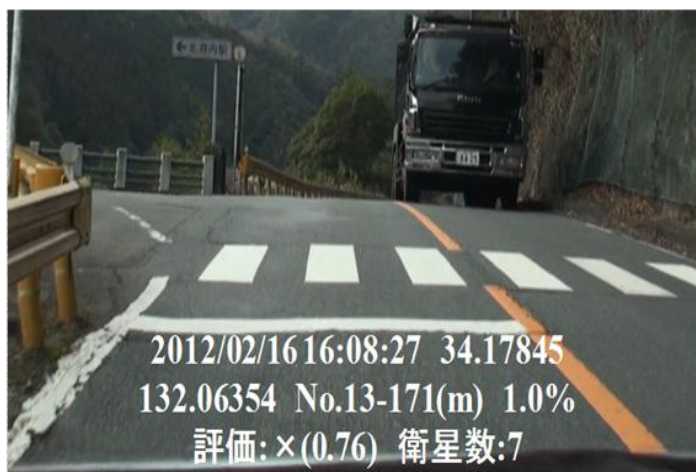
Fig.3. Example of movie file with subtitle

The measurement provides a good correlation with the road surface and at the same time, the standard deviation of running wheel sound and Z-axis acceleration by using terminated evaluation signal of running wheel sound at 150~250Hz. Moreover, data of measurement will be analyze to get the output data in varies types, that is the excel file, video and subtitle file, web map file, and road register file. The output file of evaluate data shows the specific condition of the road pavement in three differences color and sign, which are green color(good) with the symbol of ○, yellow color(moderate) with the symbol of △ and red color(bad) with the symbol of ×. Table 1 shows an example of the out data from an excel file. It can be seen from Table 1, × symbol which means the bad road condition are more dominant in it. Fig. 3 shows an example of video and subtitle file. It illustrates the situation of road by showing the sub title data through the movie file. Furthermore, Fig. 4 summarizes an example of output data which is shows the condition of the road trough web map data. It illustrates in 3 highlighted colors, red as a bad condition, yellow as moderate and green represented the good condition.
