# PROPOSAL OF A NEW ECONOMIC RETROFITTING METHOD FOR MASONRY STRUCTURES

Paola MAYORCA<sup>1</sup> and Kimiro MEGURO<sup>2</sup>

<sup>1</sup> Post-doctoral fellow, Institute of Industrial Science, University of Tokyo  
Tokyo 153-8505, Japan, paola@iis.u-tokyo.ac.jp

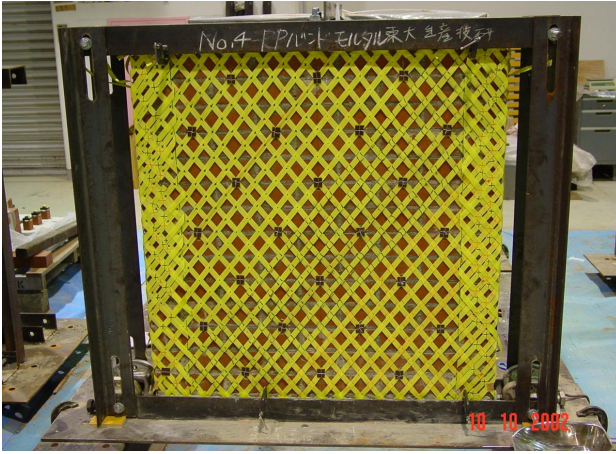
**Photo 1.** Retrofitted wall before mortar overlay setting

At first, the meshes are prepared with the PP-bands. The pitch and inclination may vary according to the required earthquake resistance. Then, the masonry wall surfaces are cleaned and holes are drilled through the wall at a spacing of approximately 4 times the mesh pitch. After this, the PP-band meshes are set on both wall sides and fixed at the borders. Galvanized steel wires are passed through the wall holes and used to fix the meshes. **Photo 1** shows the wall at this stage of the process. Finally, a mortar overlay is placed on the wall surface.

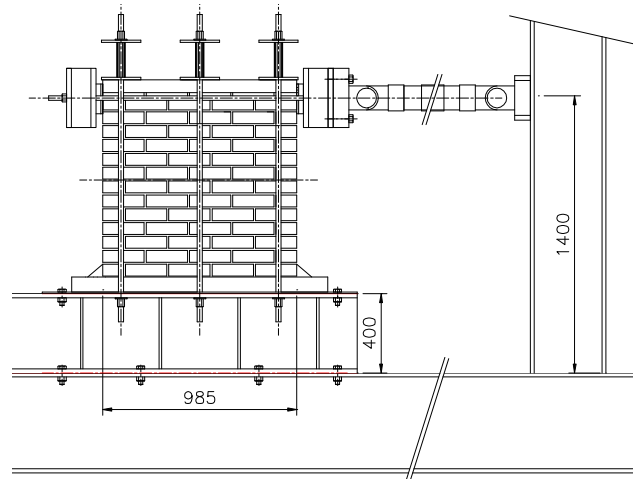
**Figure 1.** Test setup and dimensions in mm

In order to assess the retrofitting by PP-band mesh, eight masonry walls were constructed: four with and four without reinforcement. The wall dimensions were  $985 \times 1072 \times 100 \text{ mm}^3$  and consisted of 15 brick rows of 4.5 bricks each. Clay bricks were used. The mortar mix proportion in volume was cement:sand=1:4.5 and the joint thickness was 10mm. The bottom and top brick layers were embedded in steel channels. The walls were cured with water spray for 14 days. At the end of the curing process, the upper channel was installed. **Figure 1** shows the test setup and specimen dimensions.

At first, a vertical pre-compression load was applied by closing the bolts at the bottom end of six vertical rods. The force increment at the bars was closely monitored. Then, the actuator was positioned and the forces at the vertical rods were readjusted in case of unbalance. Finally, the horizontal loading, which consisted of 5 steps was applied with a hydraulic pump operated manually. In the first step, the wall was loaded until diagonal cracking. The second step consisted on additionally pushing the wall 10mm in the same direction. In the third step, the actuator displacement direction was reversed and the specimen was loaded until the diagonal crack in the opposite direction occurred. In the fourth step, the wall was loaded 10mm more in the same direction. Finally, the wall was unloaded. **Table 1** shows the experiment program summary.

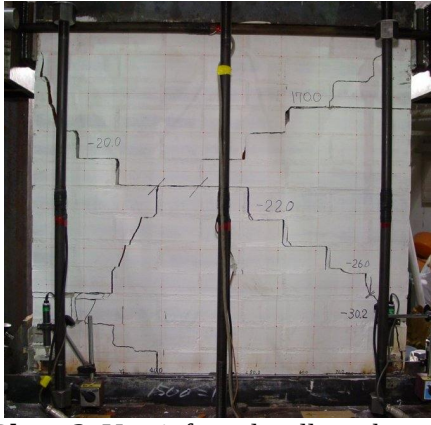
**Photo 2.** Unreinforced wall crack pattern

**Photos 2 and 3** show typical crack patterns. **Figures 2 and 3** show the force-deformation curves obtained in the experiments grouped according to the pre-compression load. The experimental observations are briefly discussed below.

As observed in **Photos 2 and 3**, the crack pattern did not change considerably due to the reinforcement presence. In both cases, the flexural stresses caused a crack at the lower most mortar layer at an early load stage. This crack became gradually longer and wider as the horizontal load increased. In the case of the reinforced walls, the crack propagated slowly and as a result, a wall strength drop was not observed in the force-deformation curve. This effect was identified in the walls with VL=9kN.

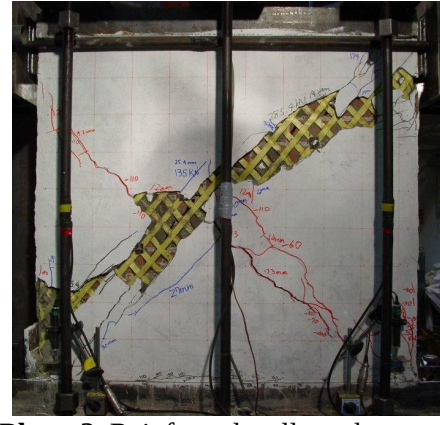
**Photo 3.** Reinforced wall crack pattern

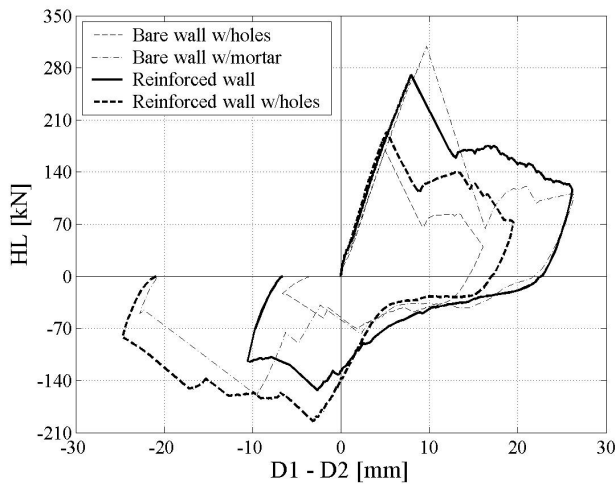
**Figure 2.** Force-deformation curve (VL=9kN)

The force-deformation curves presented in **Figure 2** may suggest that the reinforced walls have a slightly higher stiffness than the unreinforced ones. However, it must be noted that the deformations showed in the figures correspond to two effects, the wall deformation itself and the wall rotation. The later is larger. **Figure 4** shows the deformation along the wall diagonals, which is a direct measurement of the wall shear deformation. Note that the deformation of both reinforced and unreinforced

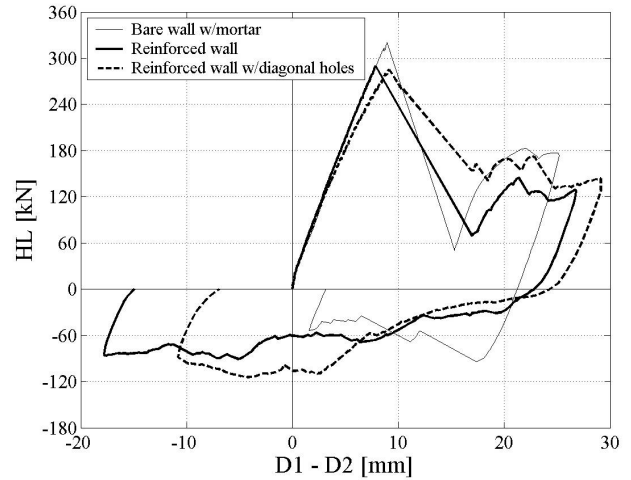
**Figure 3.** Force-deformation curve (VL=30kN)

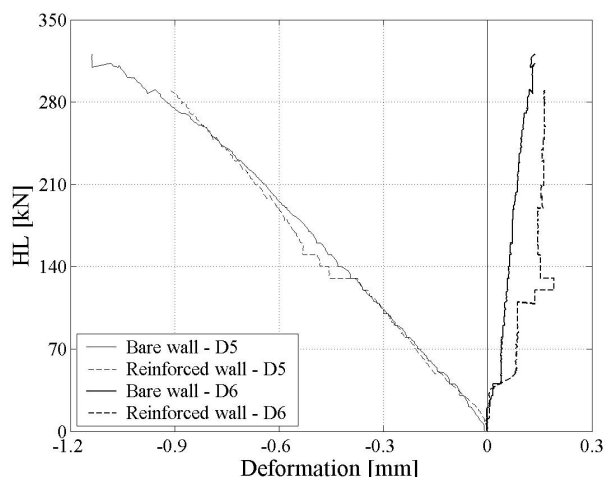
**Figure 4.** Diagonal deformation (VL=30kN)

walls is small and almost the same. This shows the high stiffness of the masonry wall and suggests that the stiffness difference observed in the force deformation curves is mainly due to the reinforcement restrain to the wall rotation.

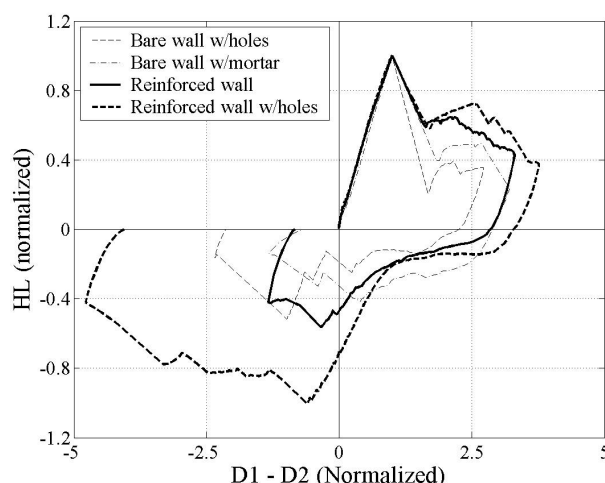
**Figure 5.** Normalized force-deformation relation (VL=9kN)

**Figure 5** shows the force-deformation relation normalized to the peak strength and corresponding deformation for the group of walls with VL=9kN. It is observed that immediately after the peak, the normalized strength dropped to 10 to 40% for the unreinforced walls. On the other hand, the reinforced walls exhibited a 60% residual strength after the peak, which was sustained even for large deformations. In the reverse direction, the reinforced walls also exhibited a larger normalized strength.
