Reduction of PP-band Mesh Connectivity for Masonry Structure Retrofitting

Key Words : *Unreinforced Masonry, Polypropylene, retrofitting and connectivity.*

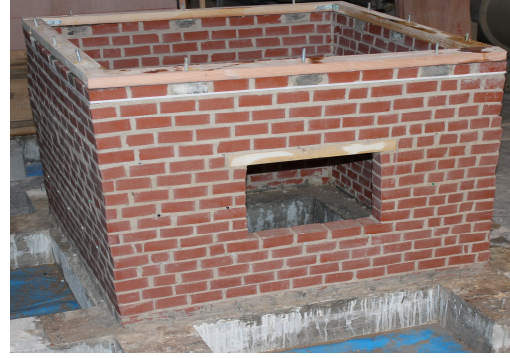
Fig.2 Model House after completion of brick work then connected with out of plane connection. The vertical Piece was attached at pitch of 50 mm with bottom piece of PP-band as shown in Fig.4.

Concrete foundation were used for building the house and form erected initially. The base dimensions of the house were 930 mm x 930 mm and 720 mm height of the house as shown in Fig.2. Brick of 75 mm x 50 mm x 37.5 mm placed in 18 having wall thickness 50 mm. Mortar having ratio cement, sand, lime ratio as (1:7.9:20) with w/c as 0.4 (water cement ratio). Wooden lintel were placed above the door and window having dimension were 245 mm x 485 mm and 245 mm x 325 mm.

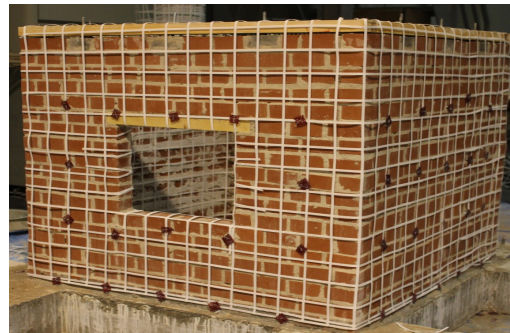
Fig.5 Fully Connected PP-band house (PPF)

After attaching all the vertical pieces and then remaining horizontal pieces are placed at pitch of 50 mm. Then connected with out of plane for remaining connections. Around door and windows were warped for better holding of PP-band and mesh fully connected at all intersection Fig.5

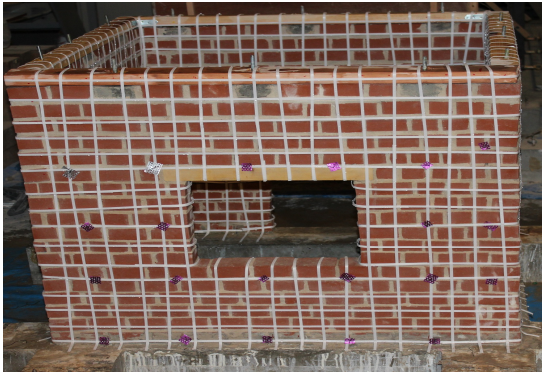
Fig.8 Non Connected PP-band house (PPN)

Warp the mesh around doors and windows opening as shown in Fig.8. The PP-band mesh is not connected with ultra-sonic welding device and only waving has been done to make the mesh.

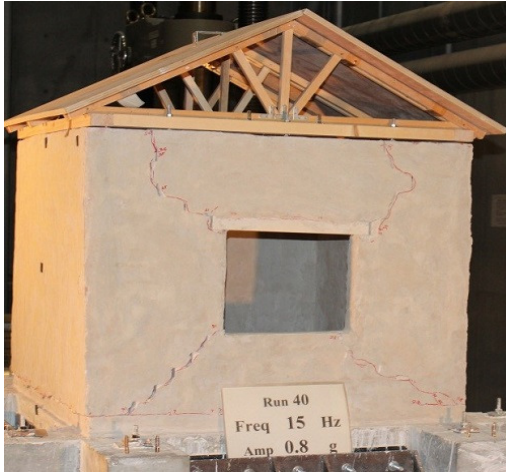
Fig.10 URM house at Run-40 15 Hz and 0.8g

URM house there were no crack before Run-26 (35 Hz and 0.4g) and small cracks appear near openings and base of the house which further grows upon successive runs. Diagonal cracks appear on all the side opening which become prominent and visible after run 31 (30 Hz and 0.8g). The house condition can seen at Run-40 (15 Hz and 0.8g) in Fig.10 showing visible diagonal cracks near the opening and horizontal crack on the other face.

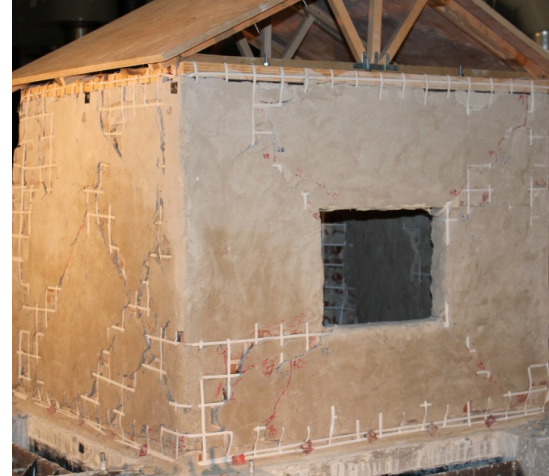
Fig.11 PPF house at Run-50 2 Hz and 0.8g

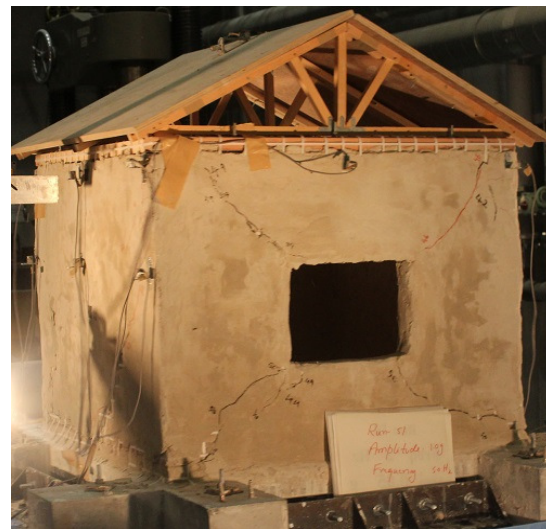
Fig.12 PPN house at Run-51 5 Hz and 1.0g

structure from the base. At Run-51 (5 Hz and 1.2 g) the mostly house was damaged at the base and remaining structure not showing damaged as shown in Fig. 12. The base suffered damaged due to the connection of PP-band at the base only. The house collapsed at the Run-54 (2 Hz and 1.2 g) similar to the fully connected PP-band house.

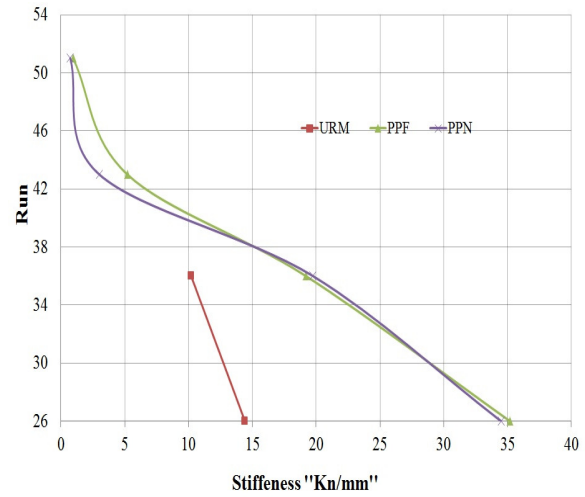
Fig.11 Stiffness Degradation curve of Houses.

The stiffness curve corresponding to the three model is presented in the Fig.11 which shows that at the initial crack of URM house at Run-26 there was 2.30 times more stiffness of the retrofitted than URM. Whereas the difference of stiffness of the both PPF and PPN is follow the same trend of degradation but during later stages loading corresponding to Run have small difference of stiffness of both model have been found.
