ESTIMATION OF FATIGUE CRACK GROWTH BY ULTRASONIC IMAGING METHOD

By Kenji SAKAMOTO, Makoto FUKAZAWA**,
Masayoshi HAMANO*** and Jiro TAJIMA*****

For a partially penetrated corner joint, estimations of the fatigue crack size and the crack growth behavior are investigated using the ultrasonic imaging method. Experimental results are obtained as follows :

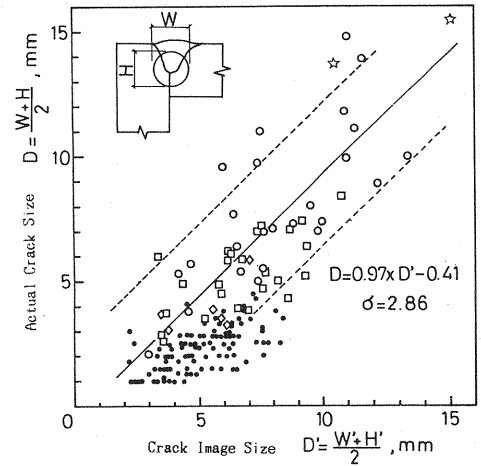
Fig. 7 Relation between crack size and image size.

In case of circular shape of the fatigue crack with a diameter of $D = (W + H)/2$, test results on the relationship between actual crack and ultrasonic image are also shown in Fig. 7. As the regression line has a gradient of almost 1.0, the size of ultrasonic image is equal to the actual crack size but the standard deviation is 3 mm. In this figure, the images of blowholes, size of which is $w \leq 3$ mm and $h \leq 6$ mm, are plotted. It shows that the blowhole was recorded as relatively large defect images, so that the crack development at the early stage cannot be decided by this relationship alone. And the test data do not show any significant difference in the correlation among the stages of crack growth.

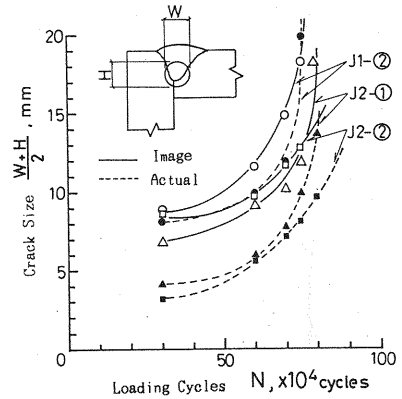
Fig. 12 Development of crack and ultrasonic image.

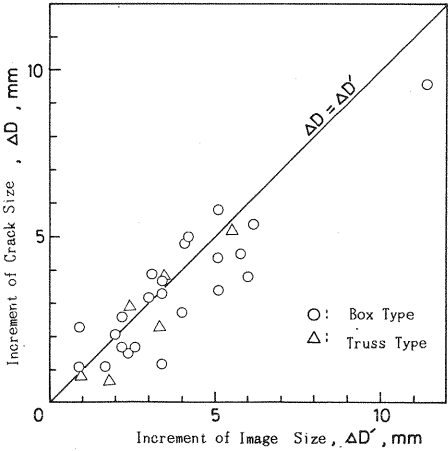
Fig.19 Relation between variation in crack size and crack image size.

Fig.19 shows the relationship between the variation in the actual crack sizes and the crack image sizes, including the test result of the box-section specimen. As an initial value, the size at the repeated cycles of 190×10^4 , when the cracks grew remarkably, was adopted for the truss panel-pointed specimen, and the size at the repeated cycles of 30×10^4 (in the initial testing) was adopted for the box section specimen. In all cases, it is observed that the variations are distributed on both sides of the following line and represent close correlation between the two.

$$\Delta D = \Delta D'$$
