STUDY ON EVALUATION METHOD FOR PAINT FILM DETERIORATION ON STEEL BRIDGE WITH IMAGE PROCESSING TECHNOLOGY

Visual inspection method involves personal errors in evaluating according to the observer's knowledge and experience in painting and paint. This study considers that the quantitative evaluation of paint film deterioration would be possible by using image processing technology and by selecting gray-scale morphology processing from among existing image processing techniques. To examine its practicability, an extraction test was conducted on 13620 photographs of actual bridge paint film. This test extracted deterioration from paint film images and calculated its area ratio. As a result, the test showed the possibility of quantitative evaluation of the deterioration and estimating the time to repaint using it.

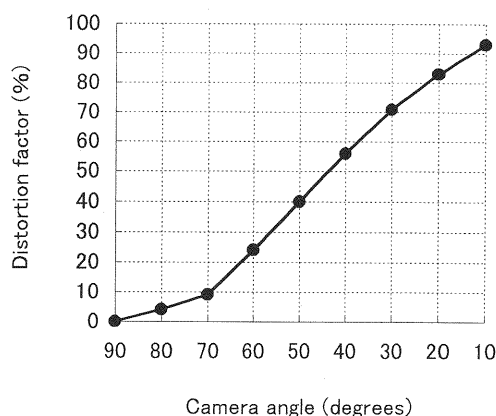
Fig. 3 Relationship between camera angle and distortion factor

Fig.3 indicates that image distortion increases rapidly for camera angles less than 70 degrees. At a camera angle of 70 degrees, the distortion factor is 9%. In other words, the actual deteriorated area becomes 9% smaller than original size when a camera angle is 70 degrees.

To examine the influence of different lenses at the same time, three lenses with focal lengths of 35 mm, 50 mm and 180 mm were used. The relation between camera angles and the distortion factor are shown in Fig.3. The distortion factor was derived using Equation (1)
