A FUNDAMENTAL STUDY ON DETECTION OF DEFECTS IN THE WEB GAP REGION OF STEEL BRIDGES BY THE PLATE WAVE ULTRASONIC TEST

Hiromi SHIRAHATA Lowell GREIMANN Terry WIPF Brent PHARES Norio NAKAGAWA

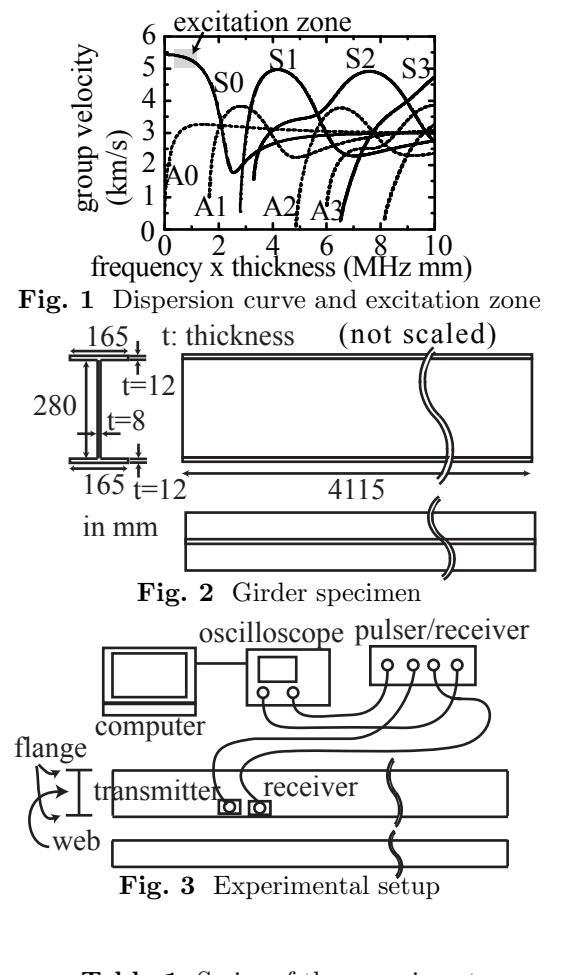
Plate waves are dispersive. That is, the phase velocity of the wave is dependent upon the frequency. As the result, the selection of an appropriate frequency is important to accomplish this. **Fig. 1** which shows dispersion curves for steel plates was used. As can be seen, an S_0 mode of around 0-1.0 MHz mm is a suitable excitation zone because the velocity is the greatest and there are only two modes present. The frequency used in this study was selected to be in that zone. The thickness of web plate of steel bridges is usually less than 10mm. The frequency should be 1.0MHz mm/10mm=0.1MHz.

Fig. 2 shows the girder specimen tested in this study. The specimen was 4100mm in the length with an 8 mm thick web plate. Fig. 3 shows the general experimental setup. A pulse-receiver, an oscilloscope, and two transducers were used to generate the required wave forms. A laptop computer was used for data acquisition.

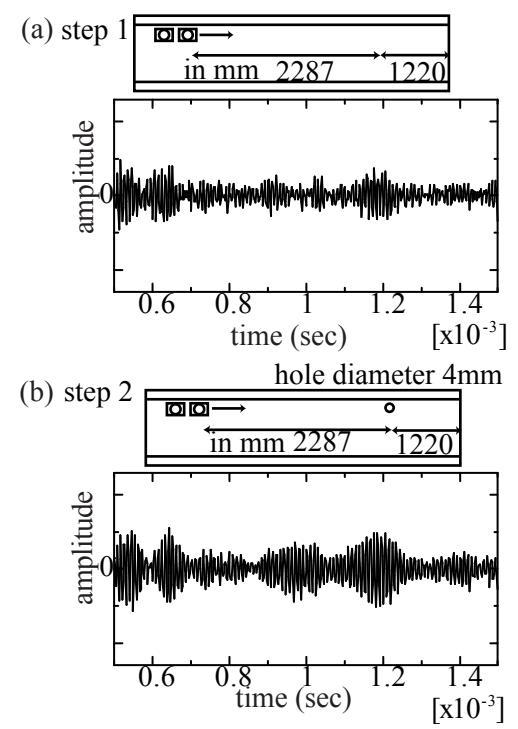
Fig. 4 Wave forms of steps 1 and 2 of series 1

Fig. 4(a) and (b) show wave forms of steps 1 and 2 of series 1, respectively. The location of drill hole is shown in Fig. 4(b). In Fig. 4(a), an echo can be seen around 1.1 msec. This echo is the signal reflection at the far end of the girder specimen. In Fig. 4(b), another echo can be seen around 0.9 msec, while it could not be seen in Fig. 4(a). This echo likely represents the presence of the drilled hole defect.

Fig. 5(a) and (b) show the wave forms for steps 1 and 2 of series 2, respectively. The location of introduced welded stiffener plate is shown in Fig. 5(b). Comparing Fig. 5(a) with (b), an echo appeared in 0.8 msec in Fig. 5(b). This echo might be a reflection at the weld.

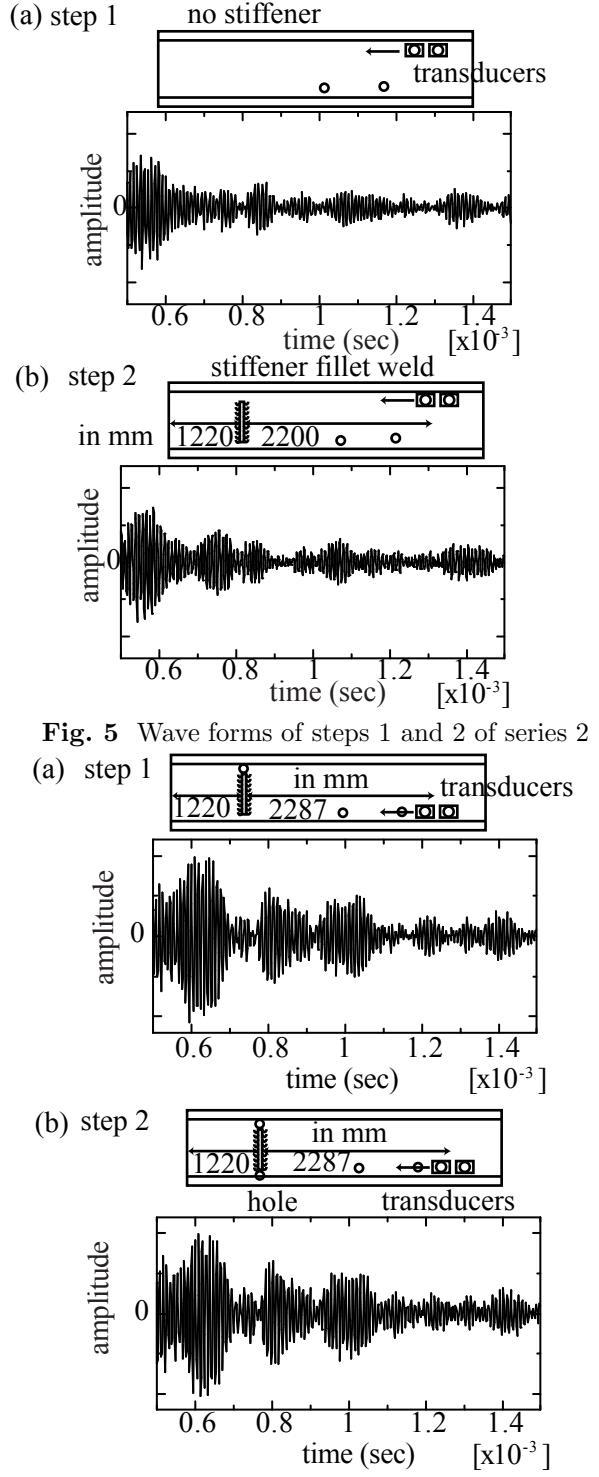
Fig. 6 Wave forms of steps 1 and 2 of series 3

Fig. 6(a) and (b) show the wave forms for steps 1 and 2 of series 3, respectively. Considering wave velocity, an echo around 0.8 msec might be from the weld portion. Echo height of 0.8 msec in Fig. 6 (b) was a little higher than that of Fig. 6 (a).
