Low Cycle Fatigue Assessment of Joint Structure in Steel Truss Bridges under Earthquake

Nagoya University Student member OChao Jiang Nagoya University Full member Takeshi Hanji Nagoya University Fellow member Kazuo Tateishi Nagoya University Full member Masaru Shimizu

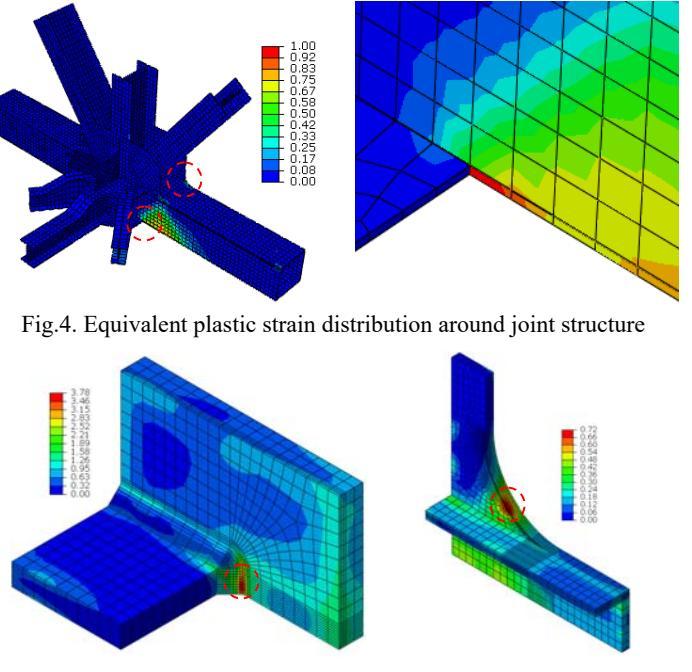
(a) Welded joint (b) Transition part Fig 5. Equivalent plastic strain distribution in local models

Fig.4 shows an example of equivalent plastic strain distribution in the joint structure model. It can be observed that the highest strain concentration generated at the boundary between a lateral gusset plate and a lower flange of main chord. Fig.5 shows an example of equivalent plastic strain distribution in the local models. The results indicate that highest plastic strain occurs

around a weld toe at the main chord side, and that strain concentration is also observed at a transition part of a main chord gusset plate but it is relatively small compared with that at the welded part of the lateral gusset plate.
