# Concrete Cracked by Expansion Agent Filled Pipes in Bond Test Specimens with Stirrups

筑波大学	学生会員	○ 下河邉大貴
筑波大学	学生会員	Syll Amadou Sakhir
筑波大学	正会員	金久保 利之

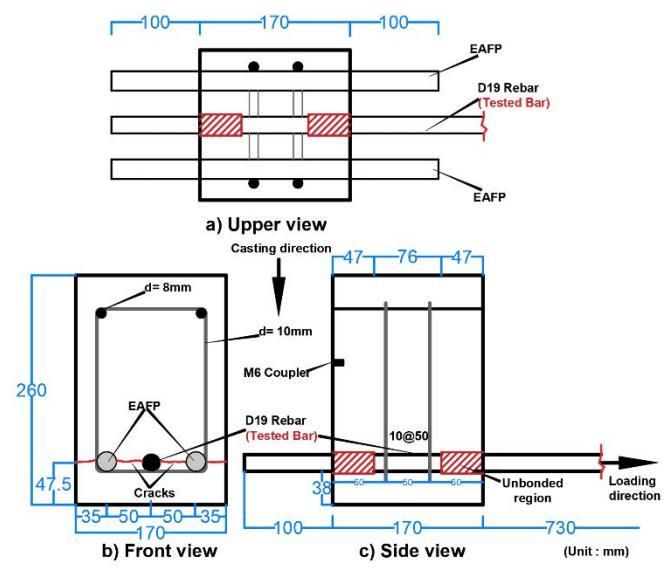
Fig. 1 Specimen detail (example Series S2)

The pull-out specimen is designed as shown in Fig.1. The dimensions of the specimen are  $260 \times 170 \times 170$  mm, and the D19 rebar is embedded at 47.5 mm from the specimen cover side. A short bond length of 4 times the diameter of the rebar equal to 76 mm is chosen to focus on the local bond behavior. The main parameters examined are the induced crack width and stirrup quantity (see Table 1). D10 rebar is used as a stirrup. Two EAFPs are set to 50 mm from the rebar to simulate the cracking of surrounding concrete. Moreover, an unbonded part was set to avoid cone failure of concrete. The M6 coupler was fixed  $100 \times 50$  mm at the upright position to set an LDVT for measuring the slip of the free end of the bar.

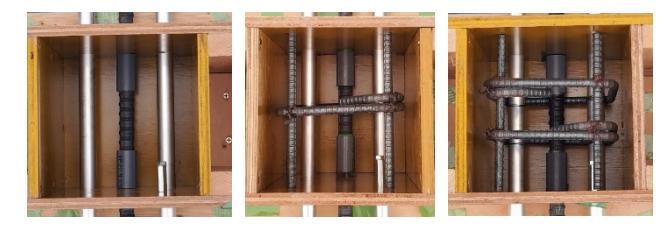
(a) Series S0 (b) Series S1 (c) Series S2 Fig. 2 Specimen framework Table 1 Specimen list

The reinforcement is a deformed bar of a nominal diameter of 19 mm. The specimen framework is also shown in Fig.2.

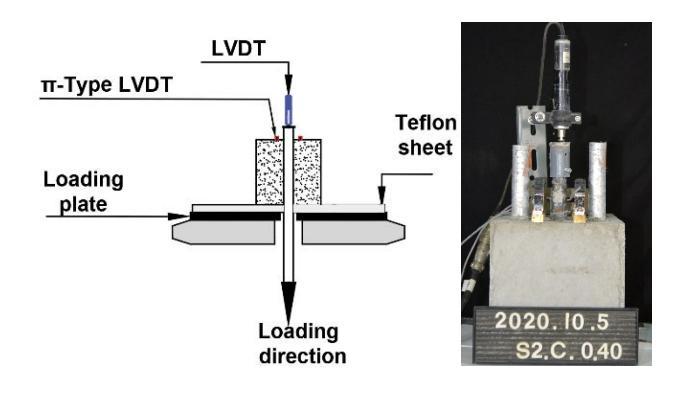
Fig. 3 shows the test set-ups for the pull-out test. The specimen was set on the Teflon sheet and the loading plate on which the hole with the same diameter corresponding to concrete cover to not restrict the lateral deformation of concrete. The D19 rebar is subjected to monotonic pull-out loading at a speed of 0.5mm/min. The measurement items are pull-out load, crack opening, and slippage of the rebar.

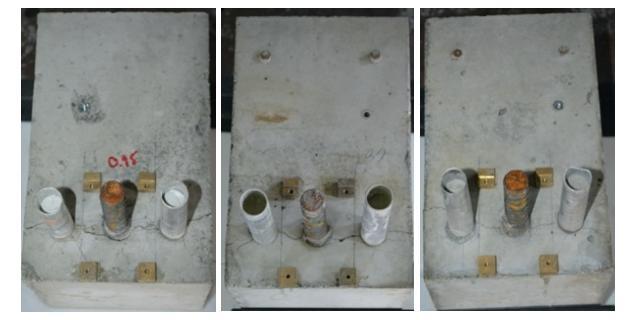
(S0-C-0.95mm) (S1-C-0.70mm) (S2-C-0.60mm) Fig. 5 Example of cracking by EAFP Before loading After loading

Fig. 5 shows an example of crack patterns after filling the expansion agent. The side split type cracks took place in all specimens. The maximum induced crack width ranges from 0.15 to 0.95 mm in S0 specimens, 0.15 to 1.40 mm in S1 specimens, 0.15 to 0.70 mm in S2 specimens.
