The Estimate on Environmental Change of Kase River Basin due to Dam Construction

Saga University	Student Member	Cindy SUPIT
Saga University	Member	Koichiro OHGUSHI

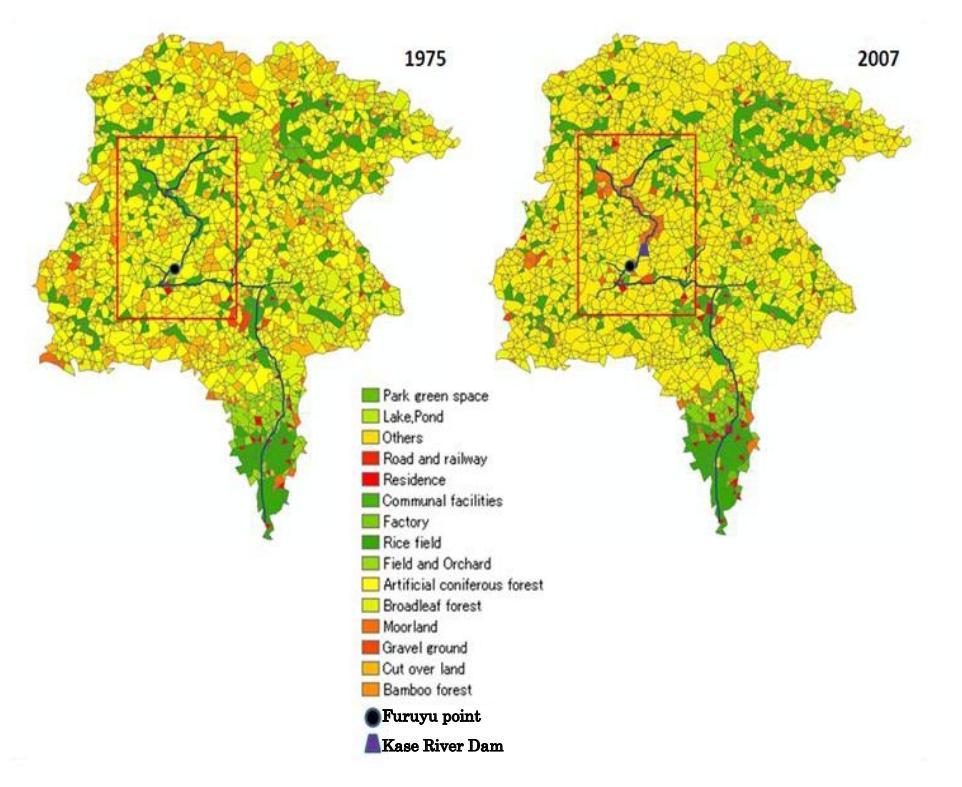
Figure 1. Land use change before and after dam construction in Kase river basin

Figure 1 visualizes a land use change before and after dam construction in Kase River basin. The inside of subset shows significant change of land use. In 1975 most of this area was rice field and artificial coniferous forest. By 2007 the orange color shows area of gravel ground or collapse ground caused by construction work.

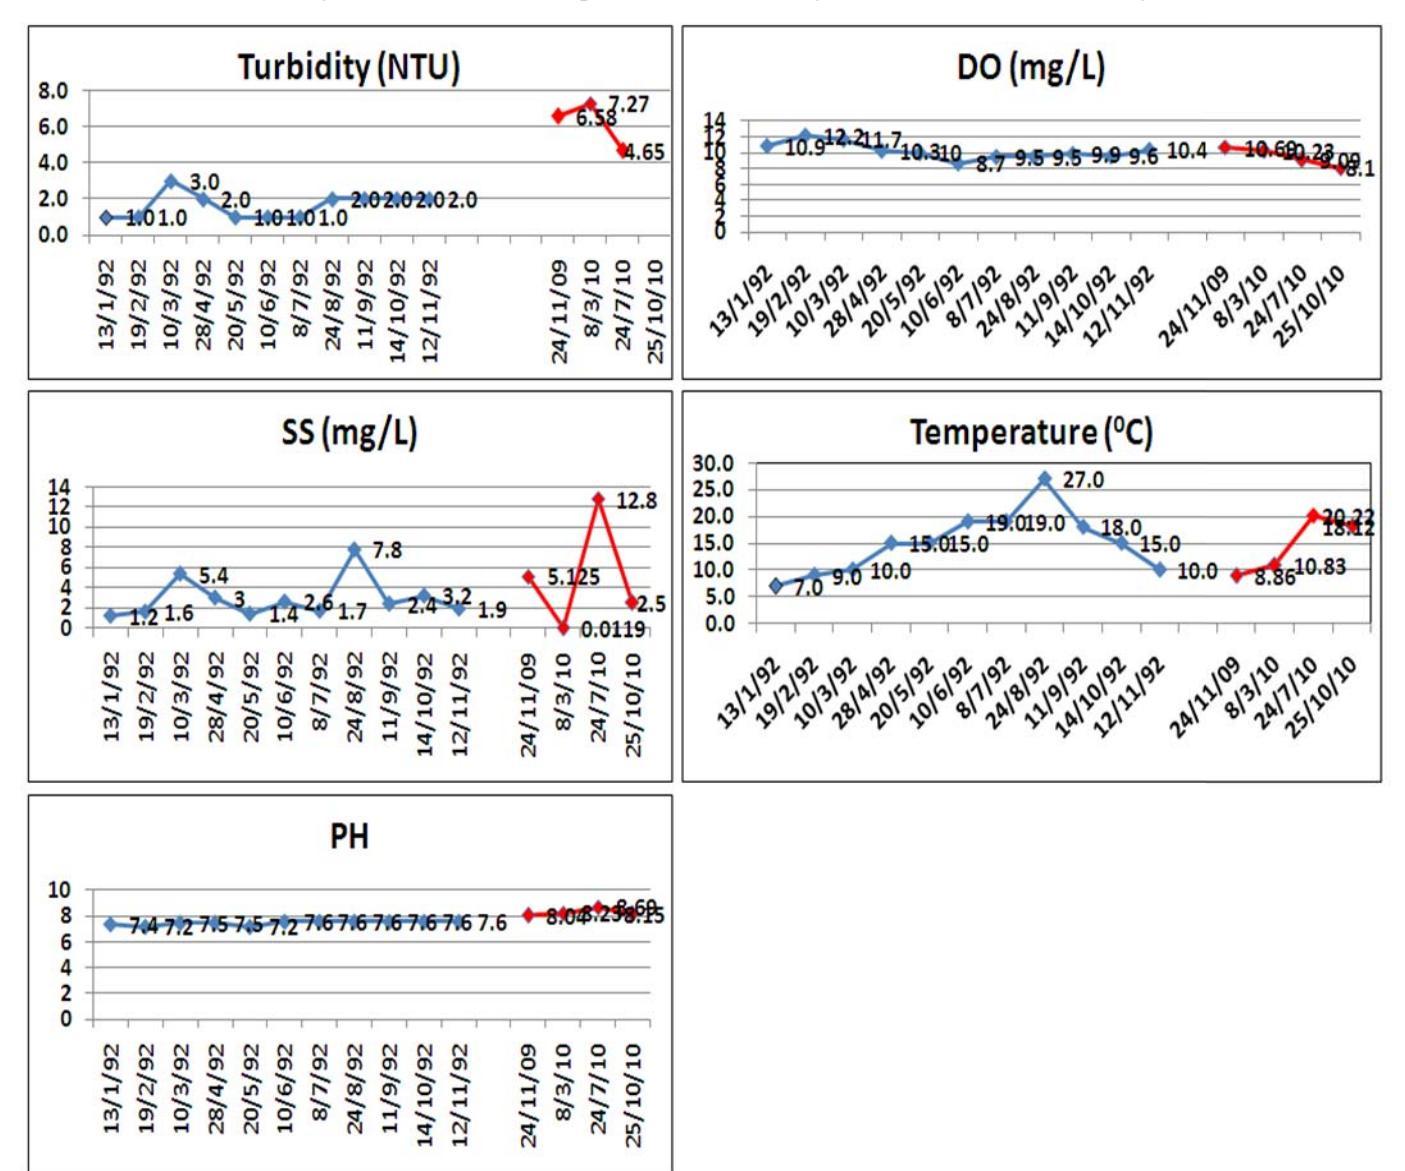
Figure 2. Water quality indices measured in Furuyu point (Blue:Before dam, Red: After dam)

Figure 2 shows the concentration of measured parameters in Furuyu, just downstream after the dam location. The value of turbidity is higher after construction work. This value shows the clarity of water may be affected by the amount of solids suspended caused by material erosion of construction work. Turbidity values before construction are between 1 and 3 NTU, and after construction its value increases between 4.65 and 7.27 NTU. Turbidity that have a value more than 30 NTU will inhibit the growth of environment organism, but from overall observation turbidity value not exceed 30 NTU. Viewed from the data, average concentration of SS after the work (5.11 mg/L) is greater than before work (2.93 mg/L), an increase in the amount of suspended solids particles in the water maybe visually describe as cloudiness or muddiness. DO is amount of oxygen dissolved in water, the ability of water to hold oxygen in solution is inversely proportional to the temperature of the water. This component in water is critical to survival of various

aquatic life in streams. In the period before construction, values of DO are higher than after construction, whose range is between 8.7 and 12.2 mg/L. After construction period DO value ranges between 8.1 and 10.69 mg/L. The DO level

becomes lower due to amount of oxygen usage in degradation process by organic substances. PH is a measure of the concentration of water, indicates the acidity or alkalinity of the water. Japan environmental quality standards posted for naturally fresh waters the PH range between 6.5 and 8.5. During the observation the PH after construction tend to be acid, but mostly still in Japan Environmental Quality Standard, only in July 2010, the PH value has a bit over the standard level. Water temperature that exceeds 18° C has a deleterious effect on environment especially for fish. Figure shows temperature over 18° C occurred in summer. Temperature before construction is in the range of 7° C- 27° C and after construction 8.86° C- 20.22° C.
