# Features of Topography and Distribution of Coastal Plants of Two Artificial Beaches in Hakata Bay, Fukuoka, Japan

Graduate School of Engineering, Kyushu University, Jinzuo LIU · Yawen SONG · Hideo KINOSHITA · Satoquo SEINO

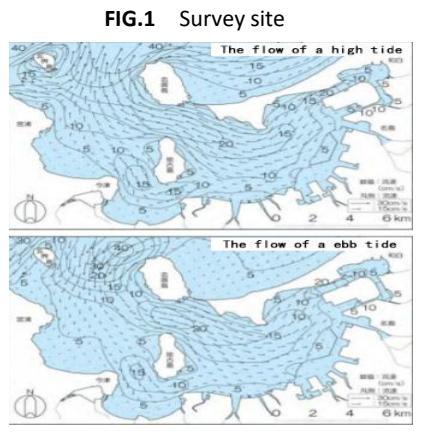
Provenance: Fukuoka City Environment Bureau FIG.2 Tideway in the Hakata Bay

The research sites of this survey are the Atagohama Coast and Najima Coast (FIG. 1) in Hakata Bay, both of which are artificial coasts constructed near landfill sites. The total length of Atagohama Coast is 1.1 km, and offshore embankments are set around the coast. Under the influence of tidal current (FIG. 2), sand drift occurs in the offshore embankments. The Najima Coast is 0.23 kilometers long, and it is a semi-open bay facing Hakata Bay with breakwaters at both ends. The Najima Coast is greatly affected by tidal current. A preliminary survey of tidal current direction and coastal erosion in the area where the coast is located. According to various factors and the nature of the coast itself, the measurement points of the terrain are selected. There are altogether 5 survey lines on the Atagohama Coast and 3 on the Najima Coast (FIG. 3).

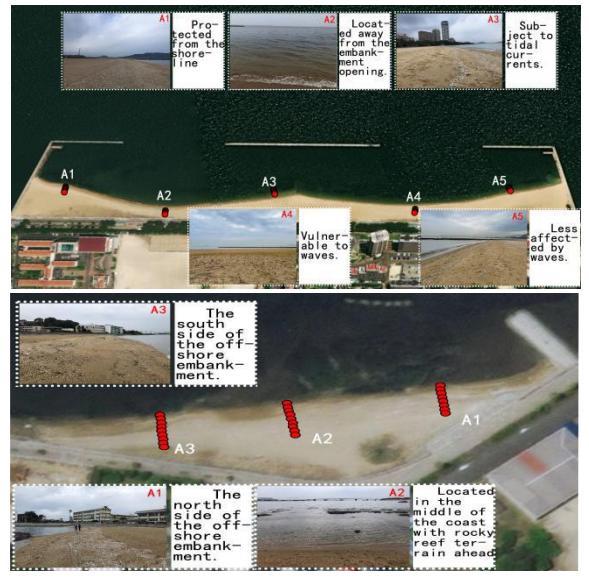
FIG.3 Measuring location

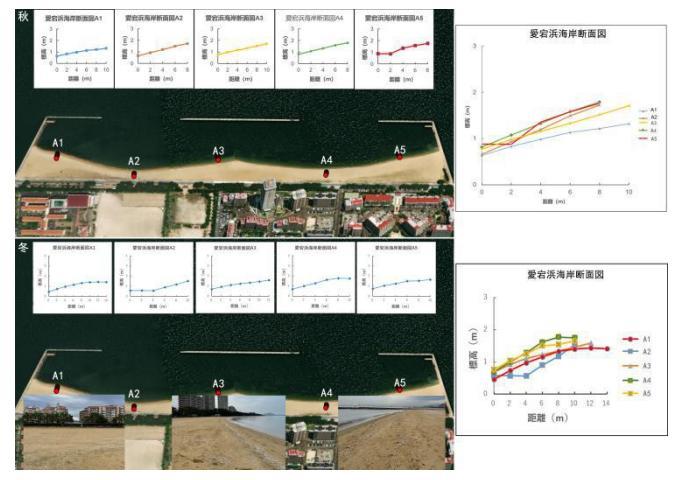
FIG.4 The Atagohama Coast topography changes

The survey conducted two topographic surveys in September and December. Select a representative area and set the measurement area from the timberline to the bank protection junction. Observation points are set up every two meters to observe changes in coastal topography and coastal erosion.

According to the survey data of the Atagohama coast, it can be found that due to the influence of the offshore embankment outside, the offshore embankment inside formed a relatively stable sea area. The overall sand loss of the beach is not obvious. The internal change of the beach is relatively clear, and the main influence is from the opening of the offshore embankment. Influenced by the tidal current of Hakata Bay, the phenomenon of coastal sand drift occurred in the interior of the offshore embankment. The slope from west to east coast, resulting in accumulation at the easternmost beach (FIG.4). The most obvious place to be affected by waves is at the opening of the embankment. The two surveys were conducted at high tide and low tide, due to changes in wave direction at high tide and low tide. The change of slope surface under impact is also very obvious.

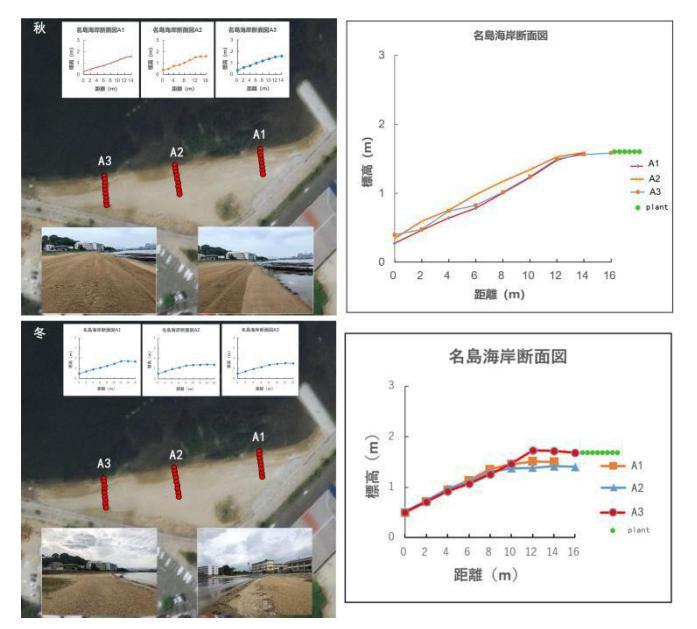
FIG.5 The Najima Coast topography changes

The Najima coast had just been repaired during the survey in September, which made it easier to observe the loss of sand. After finishing work on the Najima coast. With no protection from the shore, the sand of the beach is constantly lost, which stabilizes after a few months. The changes caused by the impact of waves are generally the same in all areas of the coast (FIG.5).
