# DYNAMIC TESTING OF MASONARY HOUSES RETROFITTED BY BAMBOO BAND MESHES

Key Words: unreinforced masonry, bamboo-band mesh, shaking table test, PP-band mesh seismic retrofit

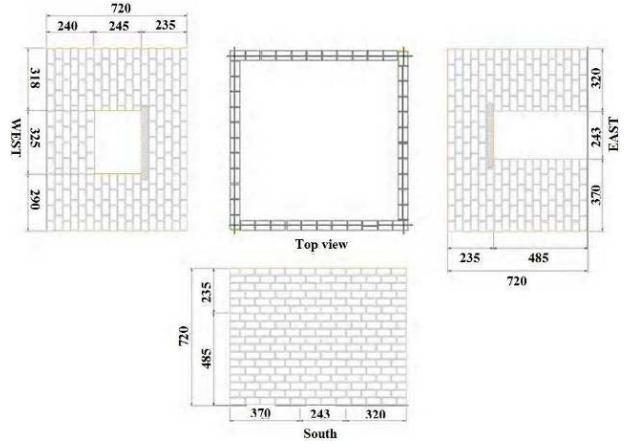
Figure 1. Model dimension (mm) (without roof)

Two models were built in the reduced scale of 1:4 using the un-burnt bricks (adobe bricks) as a masonry units and cement, lime and sand (1:2.8:8.5) mixture as mortar with c/w ratio of 0.33. Even though the materials used were from Japan, great attention was paid to make the models as true replica of adobe masonry building in developing countries in terms of masonry strength. Both models represented a one-story building with roof. As Figure 1 shows, the dimensions of both buildings were 950mm×950mm×720mm with 50mm thick walls and the sizes of door and window in opposite walls were 243mm×485mm and 325mm×245mm, respectively. The size of the adobe brick used was 75mm×50mm×35mm. Surface finishing was applied both on retrofitted and non-retrofitted buildings. These two building were identical in terms of geometry, construction materials, mix proportion, construction process and technique and other conditions that may affect the strength of the model house. The cross section of the band used was 8mm×0.75mm and the mesh pitch was 40mm. Surface finishing was applied to both specimens.

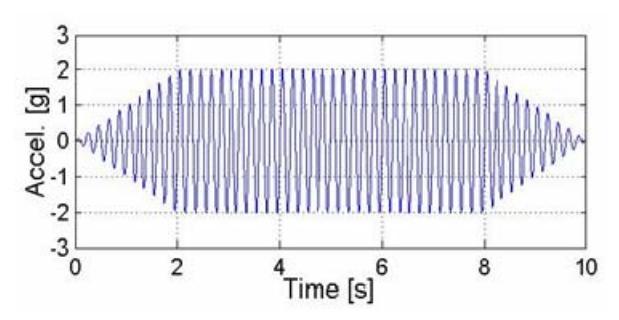
Figure 3. Input sinusoidal motion

Sinusoidal input motions with frequencies ranging from 35 Hz to 2 Hz and amplitude ranging from 0.05g to 1.4g were applied to obtain the dynamic response of both retrofitted and nonretrofitted structures. Figure 3 shows the typical shape of the applied sinusoidal wave. The number of cycles was constant for all frequencies. Thus, lower frequency input motion had longer duration. Loading was started with a sweep motion of amplitude 0.05g and frequency ranging from motion

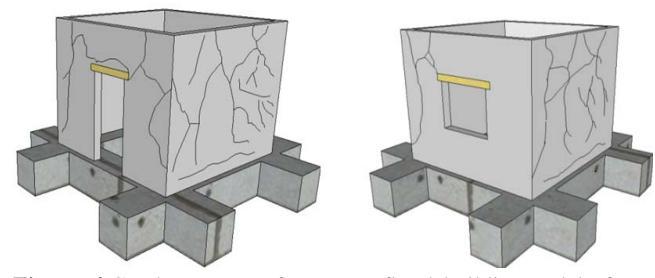
Figure 4.Crack patterns of non-retrofitted buildingmodel after 42nd run

At the end of each sinusoidal ground motion, inspection of the specimen was carried out. In addition, observed cracks were marked to highlight their locations. The crack formation for both specimens is shown in Figures 4 and 6 after the 42<sup>nd</sup> run of input motion. The initial crack patterns for both specimens were similar. However, these cracks widen in each successive loading in case of non-retrofitted model and new cracks appeared and propagated in the retrofitted model. For non-retrofitted model, no major crack was observed up to run 25. Initial crack was appeared from Run 26.At

run 26; minor cracks were observed close to connection between roof and south wall. Run 31 caused crack in point close to connection between roof and south and north wall. Similar cracks were also observed at the top of east wall and its adjacent wall. 'X' shaped cracks were observed in south wall in the run 33.

In addition, cracks from the corner of the door opening propagated up to the top layer of the wall. Existing cracks appeared from the previous run were propagated up to the bottom of the wall at run 38. Run 40 caused the falling of surface finishing from south wall. Large damages were observed in the run of 43 at which separation between east wall and its adjacent walls was occurred with the significant detachment of surface finishing from the walls. The run 44 caused the total separation of top part of the East-North corner from the specimen. At run 45, all the top part of the north and south wall totally separated from the specimen and roof was totally supported by east and west walls which are perpendicular to the shaking direction. The run 47 led the non-retrofitted building to total collapse (see Figure 5). In case of the retrofitted building model, similar cracks in the case of non-retrofitted building started from top corner of the door opening in the run 27. Run 28 caused the propagation of the existing vertical cracks to the top corner of the door opening.

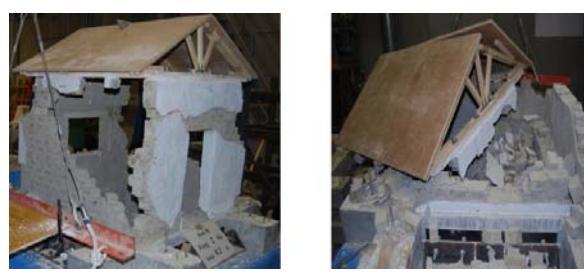
Figure 5. Non-retrofitted building model after 46 run (left) and 47 run (right)

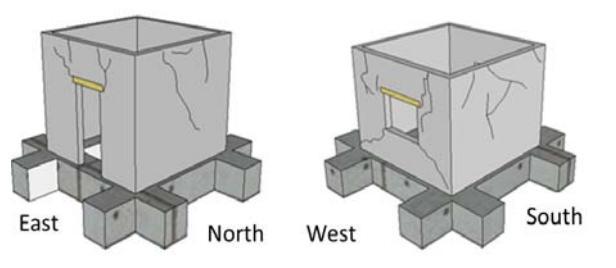
Figure 6. Crack patterns of retrofitting building model after 42run

In addition, some vertical and diagonal cracks were also observed around the window opening. The new inclined cracks were appeared in south wall at the run 40.Lots of cracks were observed at run 43. The inclined cracks originated from the corner of the window opening were extended to the top and bottom layer of the wall. 'X' shaped cracks were appeared in north and south wall with few detachment of surface finishing from the specimen. At run 47, most of the existing cracks were extended to the top and bottom layer of the walls. Most of the new cracks were concentrated in the bottom parts of the walls. This run caused the significant detachment of surface finishing from the specimen. Widening of existing cracks with the formation of few new cracks was continued to the run 49. At run 50, most of brick joints were cracked and few brick units fell down from the bottom part of the door opening. There was a large gap in some part of the specimen between the brick units and the mesh was broken at the corner of the wall. At run 52, the building lost the overall integrity and collapsed completely (see Figure 7).

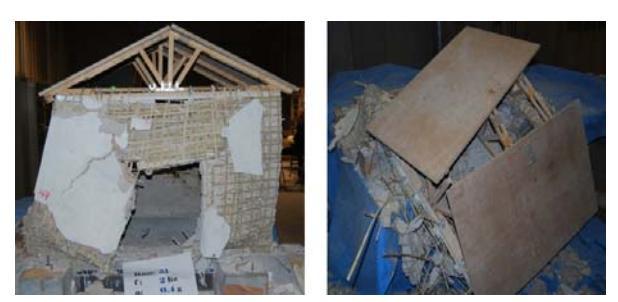
Figure 7. Retrofitting building model after 51 run (left) and 52 run (right)

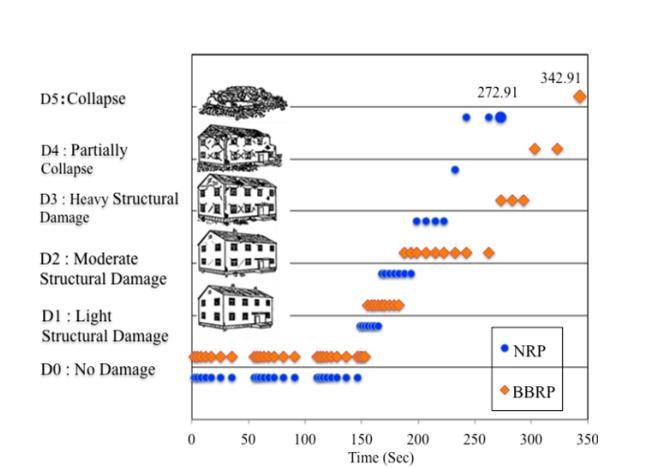
Figure 8. Damage level comparison

The performance of the models was assessed on the damage level of the building at the different level of shaking. The damage level categories are specified on the Table 2. The Japan Meteorological Agency (JMA) seismic intensity scale is normally used in Japan to indicate the severness of ground motions. JMA seismic intensity is a single number ranging from 0 to 7 and it describes the degree of shaking at a point on the Earth's surface. The JMA intensities were calculated based on the input motions to the structure at different runs. Table 3 shows the performance of model houses with different JMA intensities. The collapse of the nonretrofitting building was observed at 47<sup>th</sup> run at JMA  $5^+$ . The retrofitted model performed moderate structural damage level at 47<sup>th</sup> run at which the nonretrofitted model collapsed. Moreover, moderate performance continued to the 48<sup>th</sup> run. The retrofitted building sustained JMA 6- before going complete collapse. Figure 8 shows the to performance of the model house with respect to the duration of shaking. The non-retrofitted specimen collapsed at a time when a retrofitted performed heavy structural damage. The collapse time was extended that of 70 sec for retrofitted specimen, much longer than non-retrofitted specimen. The arias intensity was initially defined by Arias (Arias A., 1970) as

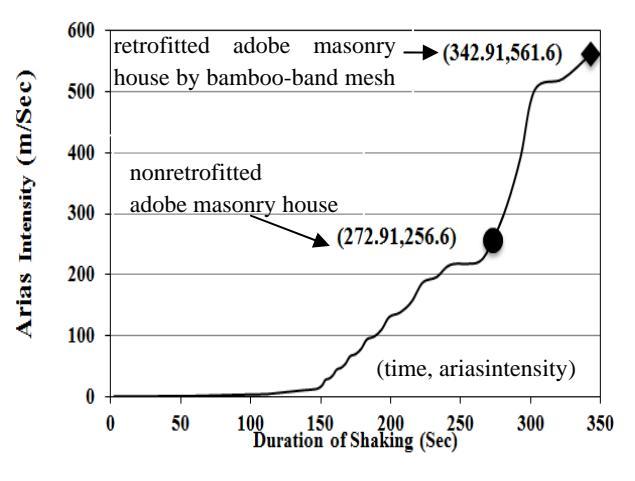
Figure 9. Seismic capacity comparison

and was called scalar intensity. It is directly quantifiable through the acceleration record a(t), integrating it over the total duration of the shaking. The arias intensity is claimed to be measure of the total seismic energy inputted to the specimen from the ground. Figure 9 shows the performance of the specimen based on arias intensity. From the results, retrofitted model could withstand over twice bigger input energy than non-retrofitted model.
