#### ⑩線路道床研究(下河原支線)

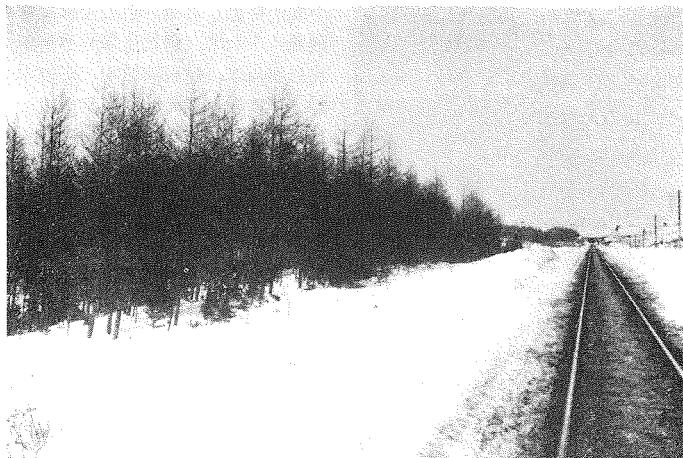
(5) 東北本線の防雪林  
(落葉松純林)

(5) A line of pine trees which will prevent the snow from attacking railway tracks. This is seen on the Tohoku line.

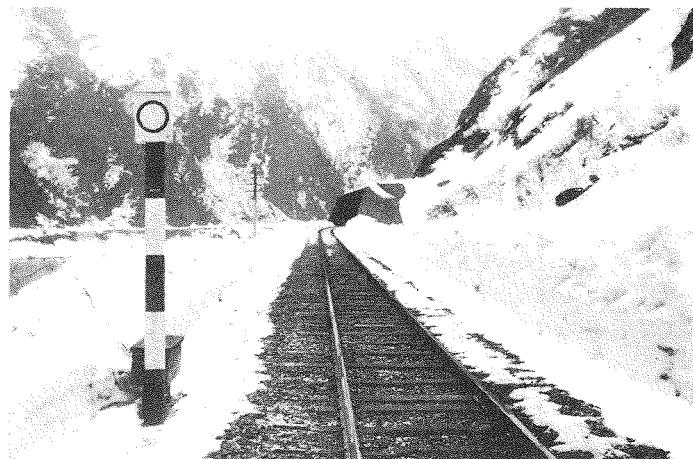
(6) 領雪警報装置(點燈による警標)

(6) In case the snow is accumulated too much, incuring danger upon the train, the signal shown here will indicate "Danger Lamp" to the operator.

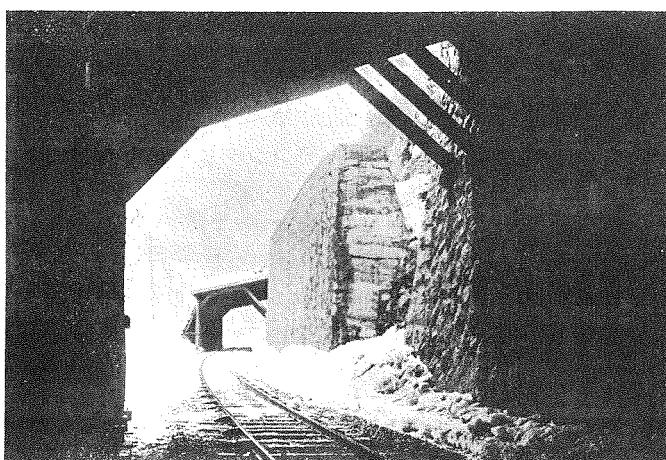
(7) 赤岩、板谷間の頸雪止擁壁

(7) One of snow danger Preventing devices. It is interesting to see how human people are struggling with the weathy snow.
