## LESSONS LEARNED OF ULTRA-RAPID HARDENING CONCRETE APPLICATION FOR BRIDGE DECK SLAB REPAIR AND STRENGTHENING IN LAOS

### 2. BRIDGE DETAIL AND CONDITION

(1) Partial replacement of the bridge deck

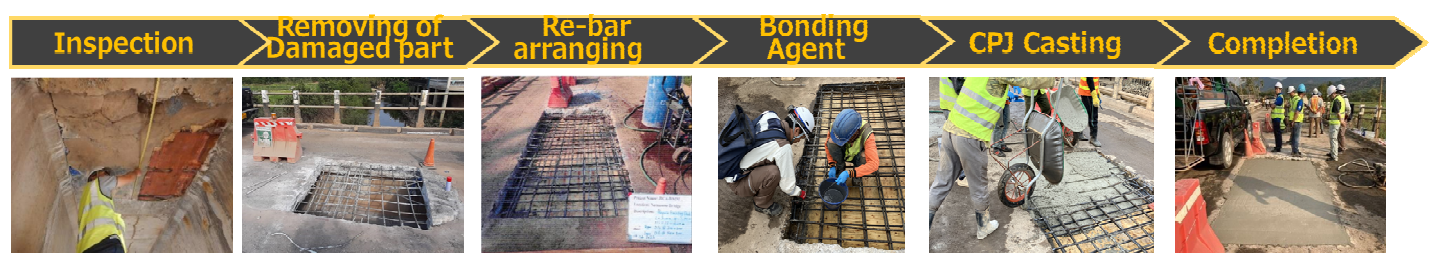
Figure 1 Procedure of partial replacement

For the partial replacement of the bridge deck, the repair area of concrete was removed, and arranged reinforcement bars.

For increasing the bonding strength between the existing bridge deck and the newly casting deck, primer was applied as the bonding agent before casting URHC using the same material as the 2nd batch of plant trials.

The construction process is described in Figure 1. Fresh mixes were checked for their properties, cylindrical concrete samples were collected and tested for several ages to ensure to meet the target strength of more than 24 N/mm<sup>2</sup>.

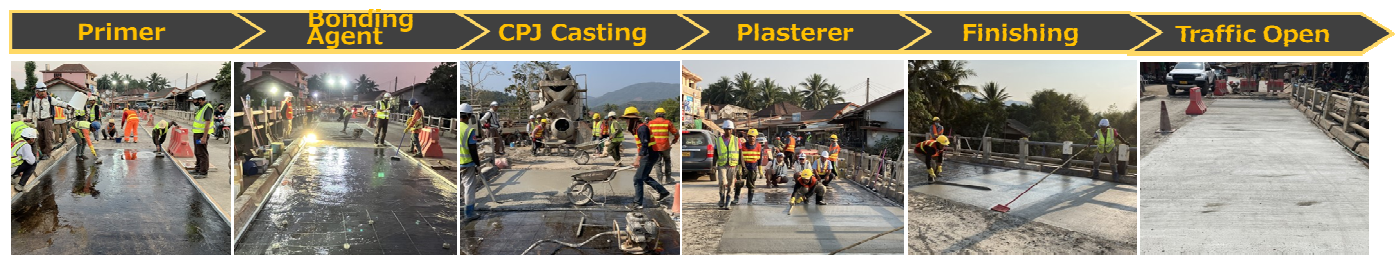
Figure 2 Procedure of the method of increasing thickness

The construction process for increasing the thickness of the bridge deck is described in Figure 2. Increasing the thickness of the bridge deck was also completed successively, and it upgraded from a thickness of 16cm to 21cm at least as described in the repair design document of the project. However, several cracks were found after the traffic reopened: the cracks occurred partially on the newly-paved bridge surface after one week and gradually developed and emerged in the full area after two weeks. As possible reasons of these cracks, dry shrinkage, partial inadequate bonding, and overloading are considered. However, these have not been determined yet as of now, although the technical investigation has been done particularly.
