# FATIGUE STRENGTH OF CORNER WELDS OF TRUSS CHORDS CONTAINING BLOWHOLES

One box section member whose dimensions were almost equal to the truss chord of the Akashi Strait Bridge was tested under repeated bending by using a 4 MN fatigue testing machine. The four corner joints consist of partially penetrated groove welds from outsides and fillet welds from insides. These corner joints contain blowholes with various sizes at the roots. The fatigue strengths of corner joints decrease remarkably with the increasing of blowhole size at the root of corner joints.

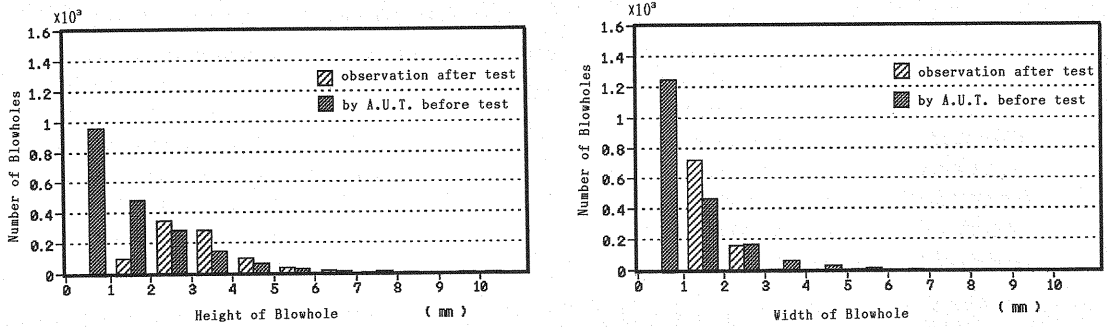
Fig.2 Sizes of Blowholes

Approximately 900 blowhole-like defects were confirmed as a result of nondestructive testing. The

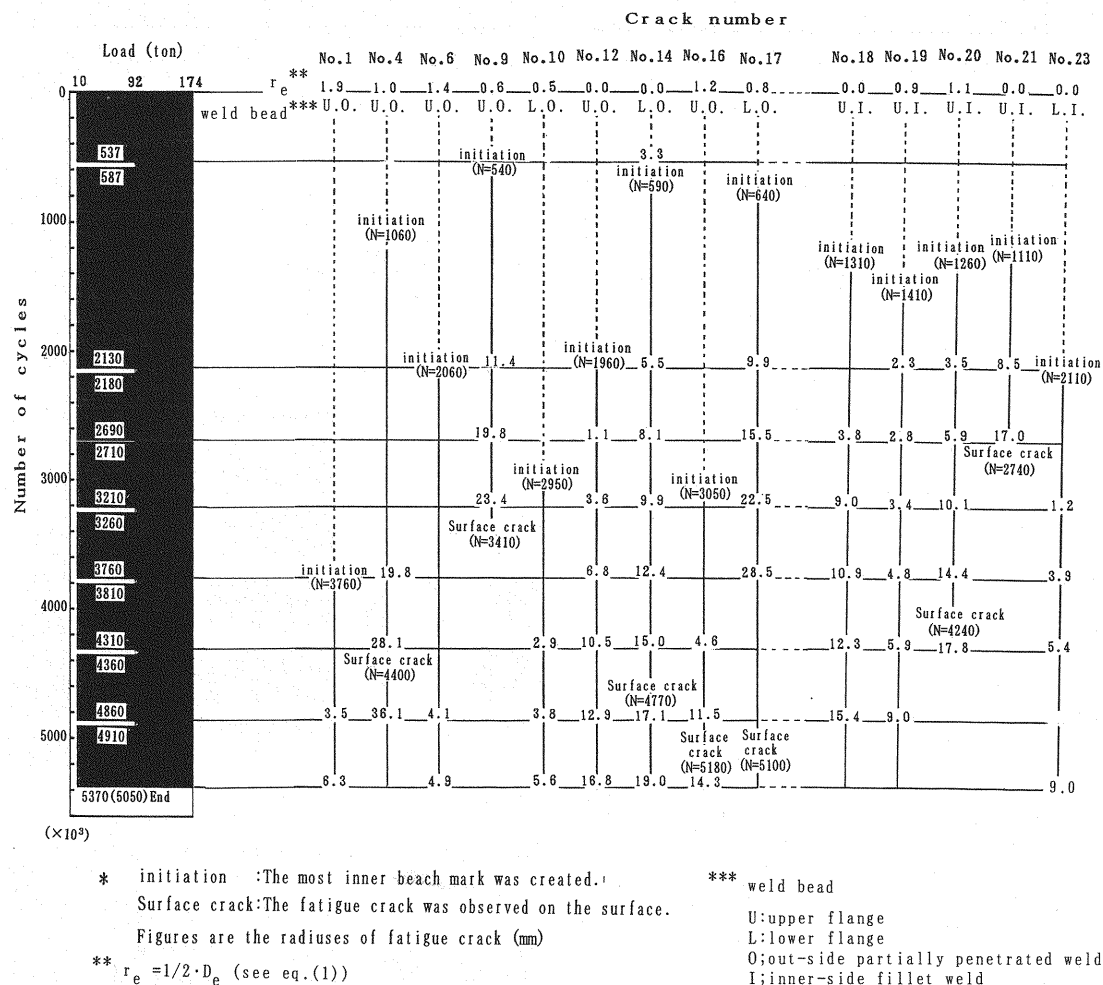
**Fig.5** Load History, Initiation and Propagation of Fatigue Cracks

The progress of fatigue testing, and the conditions of fatigue crack occurrence at corner welds and discovery of the cracks at the surface are shown in Fig.5. There were 14 cracks for which beach marks were recognized on the failure surface out of the 29 discovered fatigue cracks upon root exposure observation. The fatigue crack initiation

life in Fig.5 is considered to have been when the innermost of the beach marks remaining on the fatigue crack surface was formed.

Fatigue cracks discovered on the surface of outside single-bevel groove welds were nine, all of which had initiated from weld roots and had grown to appear at the surface. Of the nine fatigue cracks, five cracks were in the compression flange (upper flange). Fatigue cracks discovered on the surface of inside fillet welds were at two places. Crack No.21 was judged to be a fatigue crack existing inside through automatic ultrasonic testing performed at 2 million cycles of loading, and subsequently was discovered at the surface of the specimen at 2.62 million cycles.

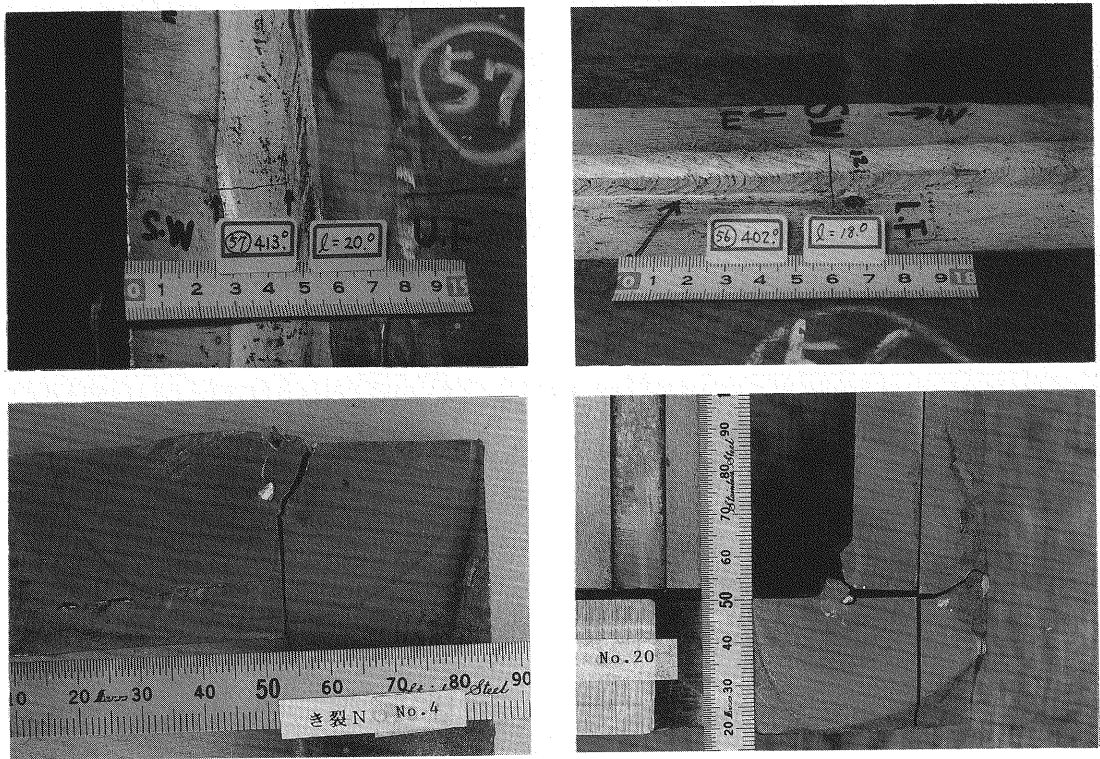
Fig.6 Fatigue Cracks

Examples of the appearance of a fatigue crack on the surface and of a fatigue crack surface are shown in Fig.6. The conditions of development of fatigue cracks from blowholes are shown in Fig.7. The dimensions of fatigue cracks at the various stages were read from beach marks remaining on fatigue crack surface when the cracks were exposed after testing, and correspond to the diameters of roughly

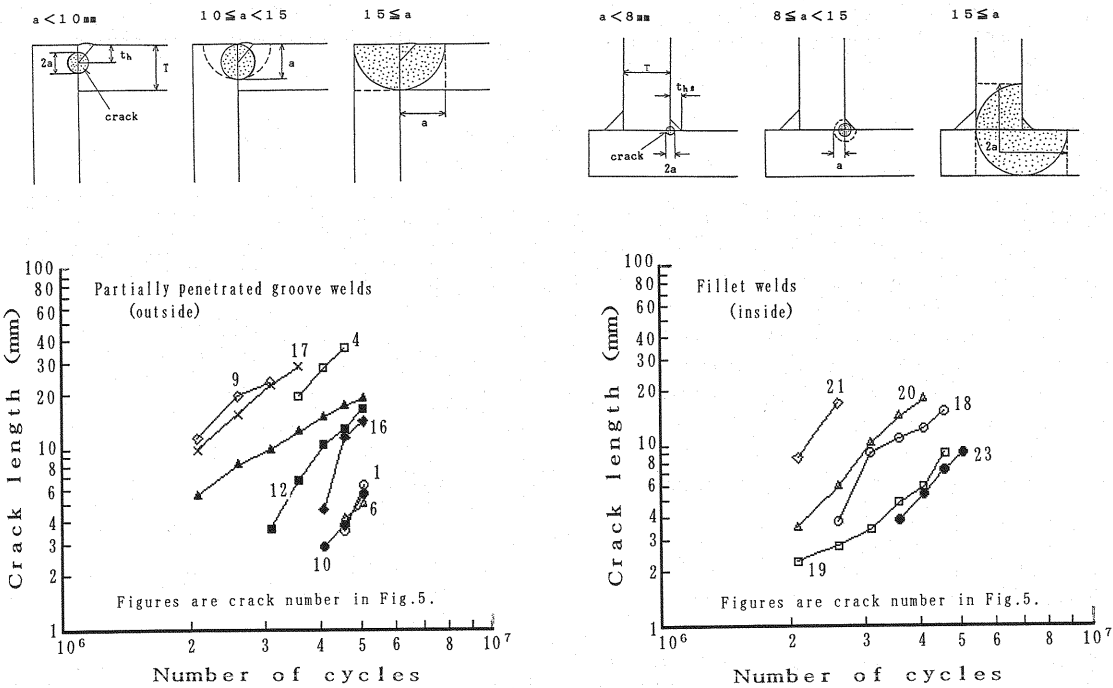
Fig.7 Changes of Fatigue Crack Size

disk-like cracks.

in Fig.7. Fatigue crack length of 10mm, corresponds roughly to the size when the crack appears at the surface. In fatigue design of corner joints in Honshu-Shikoku Bridges, the time when a fatigue crack initiated at the root has grown to the surface is taken to be the fatigue life, and crack length of 10mm corresponds roughly to this definition of life. The relationships between the nominal stresses of the various fatigue cracks and life for crack length of 10mm are scattered over a wide distribution range, and there are some which are lower than the Category D design curve.

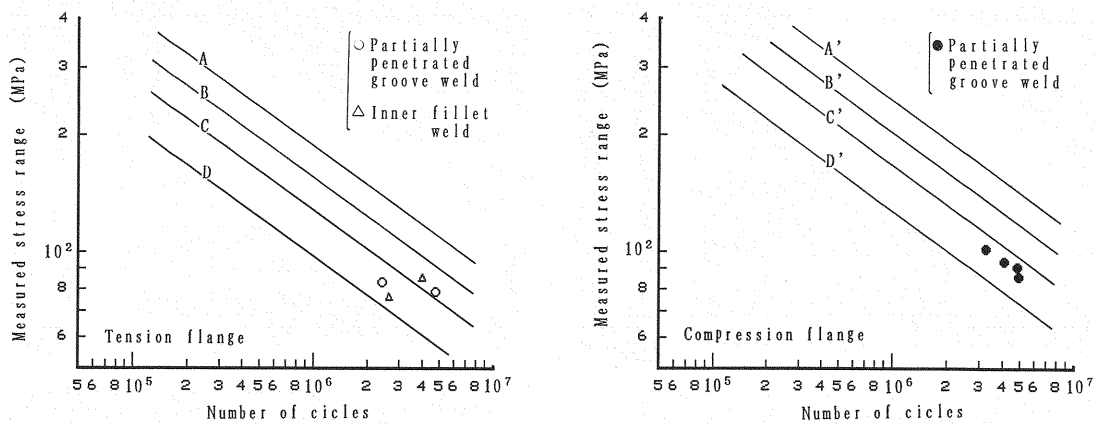
Fig.8 Fatigue Test Results (Measured Stress Range v.s. Fatigue Crack Detected Life)

The relationships of stresses measured in the vicinities of locations where fatigue cracks were detected at surfaces and the number of cycles of loading at the times of discovery are shown in **Fig.8** separately for compression sides (upper flange) and tension sides (lower flange). The straight lines A,

B, C and D, and A', B', C', and D' are the allowable stress range lines in fatigue design standards for Honshu-Shikoku Bridges. For repetitions of compressive stresses, 1.3 times the allowable stress range for tensile stresses is taken. The test results are plotted in the vicinity of the category C design line for the tension side, and slightly below the Category C' design line for the compression side. This is a fairly low fatigue strength compared with the results of large-scale fatigue tests previously carried out because of the existence of large blowholes<sup>7)</sup>.

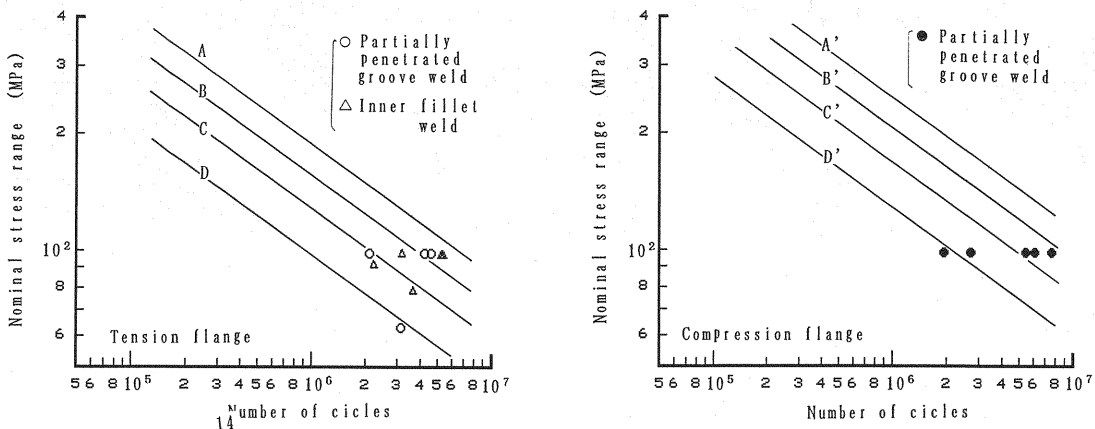
Fig.9 Fatigue Test Results (Nominal Stress Range v.s. Fatigue Life with 10mm Fatigue Crack in Diameter)

The size of fatigue crack on the surface when they were detected were varied. **Fig.9** shows the relationship between nominal stresses at the locations of cracks seeking the life and predicted fatigue lives when all fatigue cracks, including those discovered through exposure of roots after testing, had reached lengths of 10 mm, based on the condition of fatigue crack growth such as shown

In the fatigue design standards for Honshu-Shikoku bridges, when the quality classifications of Grade AA and Grade A are satisfied, allowable fatigue stress of Category B is used. Corner welds of quality classification Grade B are applied to truss members of acting stress range/allowable fatigue stress range out more than 0.5. The allowable stress range for Category B is 12.75 kg/mm<sup>2</sup> at 2×10<sup>6</sup> cycles, and 0.5 of this is 6.4

kg/mm<sup>2</sup>, lower than the 8 kg/mm<sup>2</sup> for Category D. That with the experimental results here, joints of Grade B are safe at allowable stress of Category D is indicated, and it may be said that fatigue design

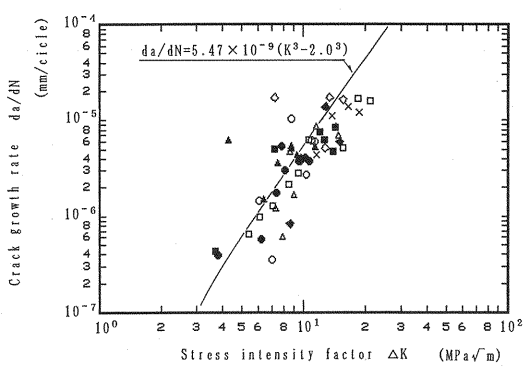
Fig.10 Fatigue Crack Propagation Rate and Stress Intensity Factor Range, obtained from Beach Marks

Fig.10 shows plots of fatigue crack growth rate  $da/dN$  [mm/cycle] obtained from the spaces of beach marks and stress intensity factor range  $\Delta K$  [MPa√m] calculated from sizes of beach mark remaining on the individual fatigue failure surfaces. The straight line in the figure is the fundamental fatigue crack growth curve used when obtaining the allowable stress range and critical flaw dimensions<sup>9)</sup>, and agree well with the  $da/dN$ - $\Delta K$  relationship obtained here from beach marks. This indicates that the modeling of fatigue crack from blowhole and the fundamental fatigue crack development curve had been appropriate.

(3) The relationship of  $da/dN$ - $\Delta K$  which were obtained from beachmarks on the fatigue failure surface are very close to the fundamental  $da/dN$ - $\Delta K$  curve of fatigue design.

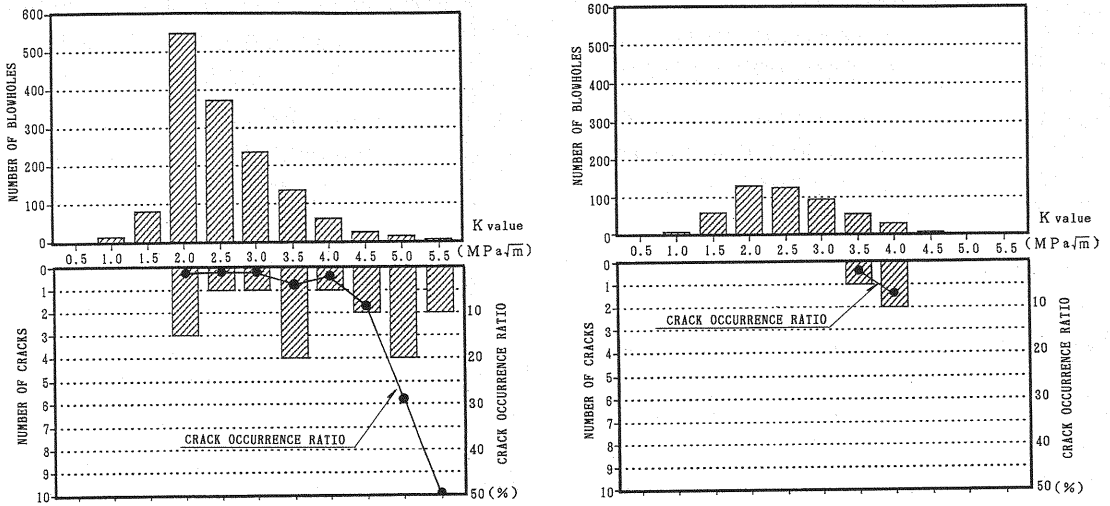
Fig.11 Distribution of Initial K values from Equivalent Diameters, Number of Cracks and Crack Occurrence Ratio from Blowholes

Fig.11 shows the distributions of initial stress intensity value which are calculated from converted diameters of blowholes, numbers of blowhole from where fatigue cracks had occurred and crack occurrence ratio from blowholes. The converted diameter is the diameter when the blowhole is considered as a fatigue crack of equivalent disk shape, and is given by the equation below<sup>9)</sup>.

$$\text{Converted Diameter } D = 0.94 \times W^{0.29} \times H^{0.48}$$

provided that W and H are width and height of blowhole, respectively. Crack occurrence ratio is the ratio of the number of blowholes from which cracks occurred to the total number of blowholes occurring at the entire lines of longitudinally-

A trend for fatigue crack occurrence ratio to become higher as the stress intensity factor of converted cracks becomes larger is seen, with the occurrence ratio rising sharply from 4 to 5 MPa√m. Fatigue cracks did not occur when stress intensity factors were not more than 2 MPa√m. This 2 MPa√m coincides with the threshold value of fatigue crack growth used for calculation of repair limit dimensions of blowholes<sup>7)</sup>.

(4) The ratio of fatigue crack occurrence from blowholes becomes higher as the stress intensity factor for cracks converted from blowholes becomes higher. Fatigue cracks do not occur when the stress intensity factor is not more than 2 MPa√m.
